Willard

5015 Garfield

REUSE ASSESSMENT

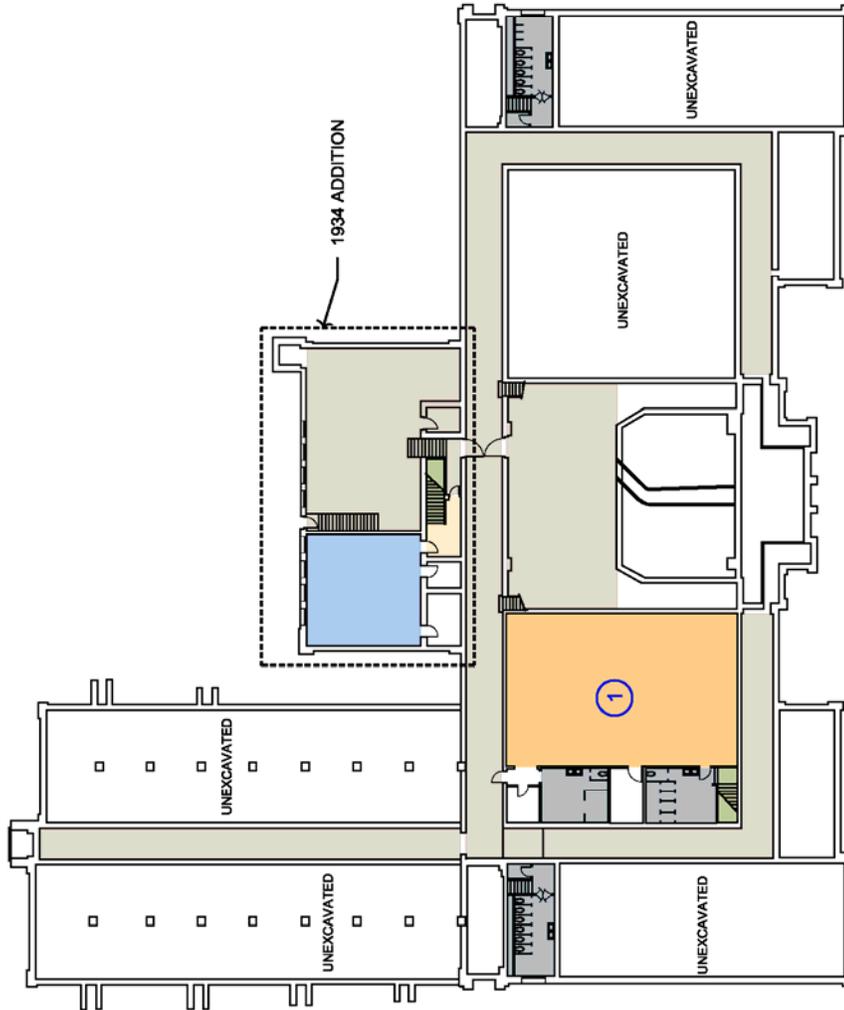
Basement

- A. Building exterior requires masonry repointing typical
- B. Concrete stairs are damaged
- C. Retaining wall is rotating and damaged
- D. Hole in roof at this location

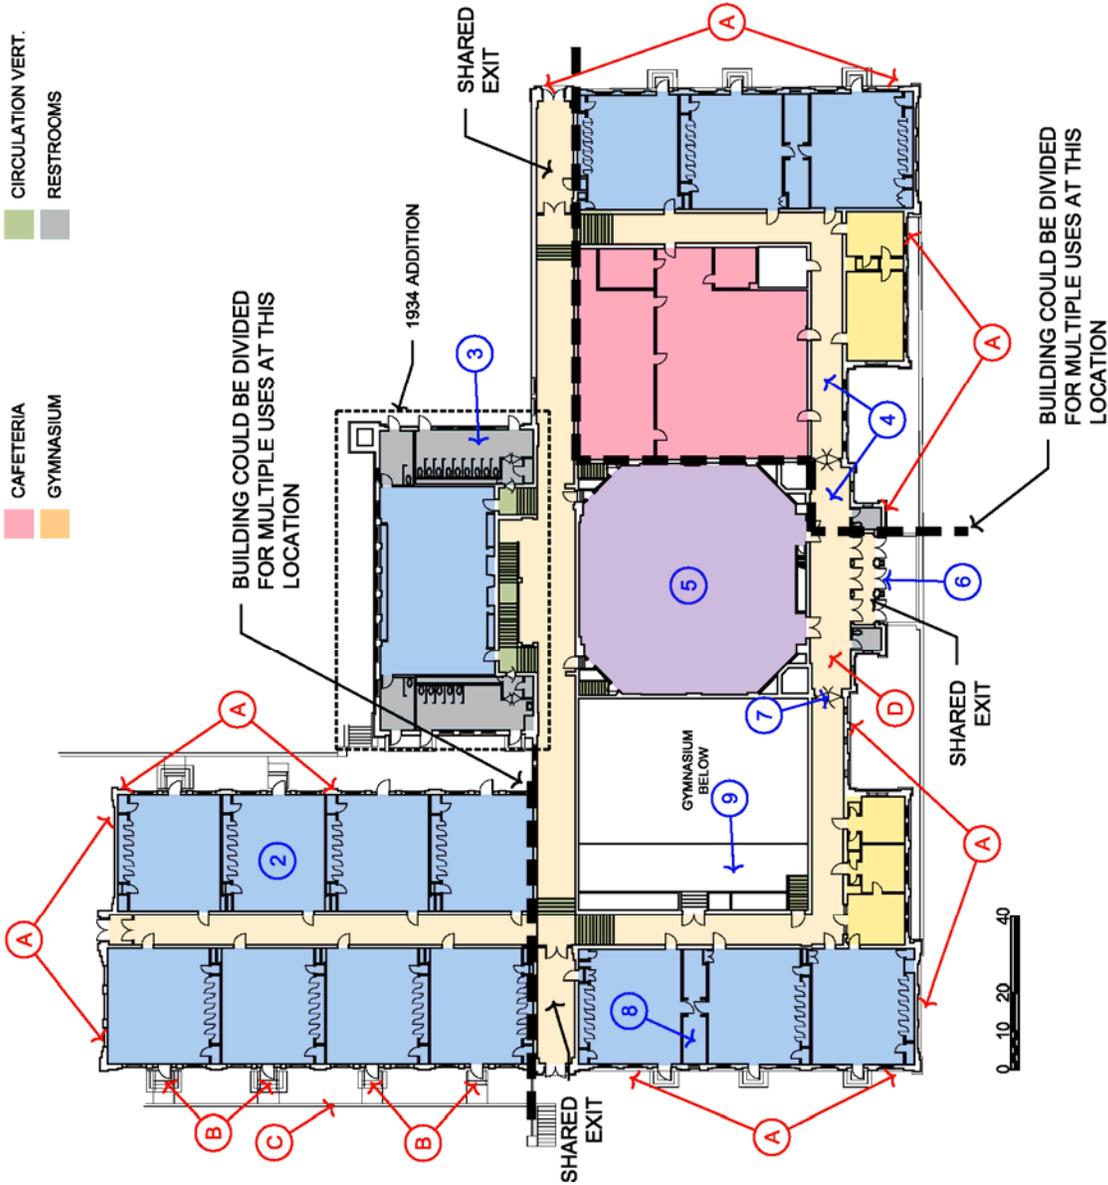
First Floor

- A. Building exterior requires masonry repointing typical
- B. Concrete stairs are damaged
- C. Retaining wall is rotating and damaged
- D. Hole in roof at this location

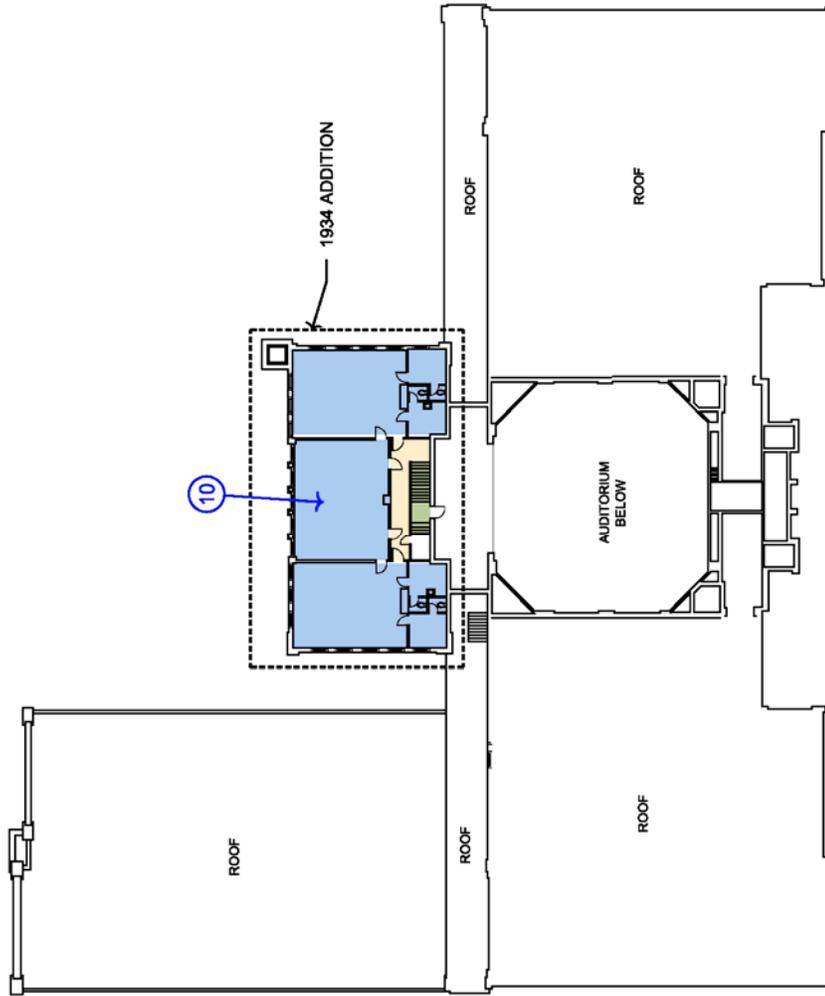
Second Floor

- A. Building exterior requires masonry repointing typical
- B. Concrete stairs are damaged
- C. Retaining wall is rotating and damaged
- D. Hole in roof at this location
