Northeast Middle

4904 Independence Avenue

REUSE ASSESSMENT

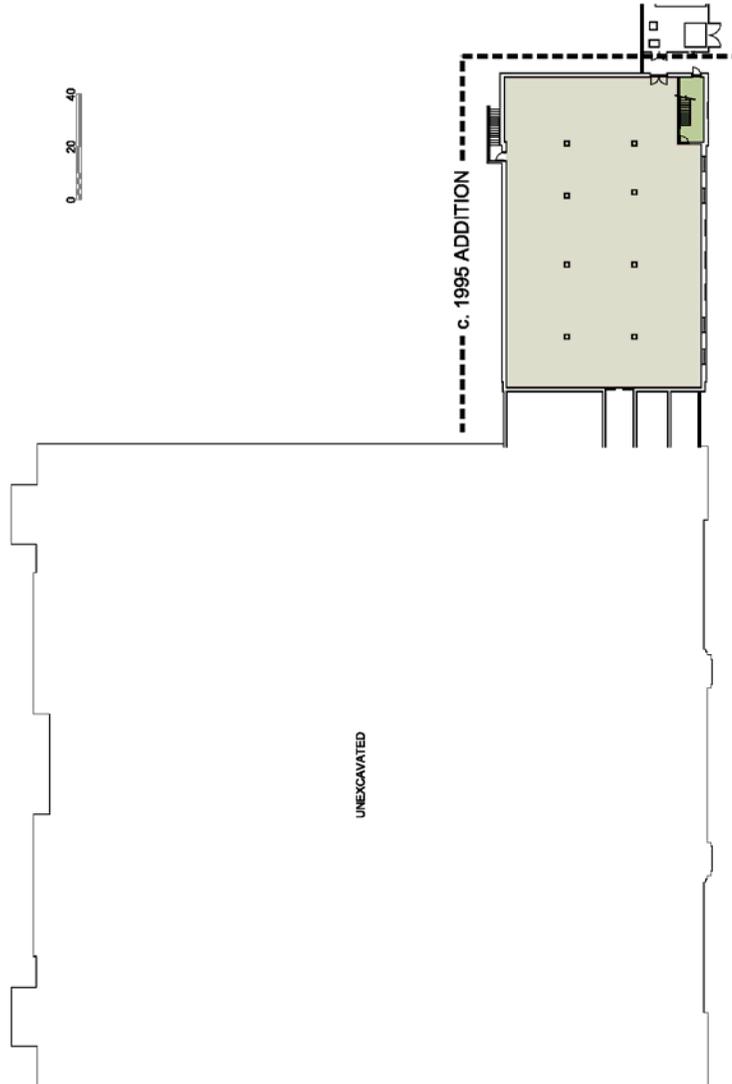
Basement

- A. Buckling wood flooring
- B. Damaged lay-in ceiling tile
- C. Water leak
- D. Graffiti
- E. Damaged window sash

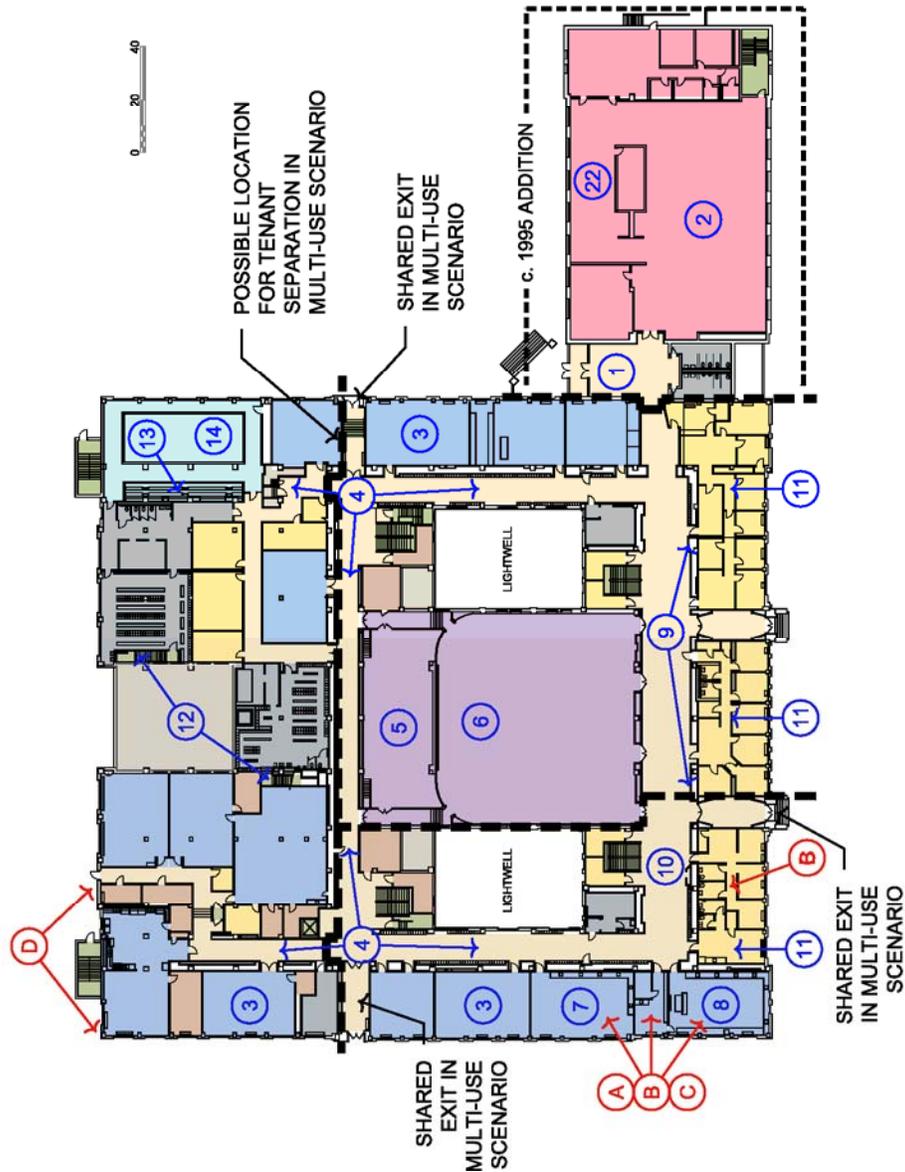
First Floor

- A. Buckling wood flooring
- B. Damaged lay-in ceiling tile
- C. Water leak
- D. Graffiti
- E. Damaged window sash

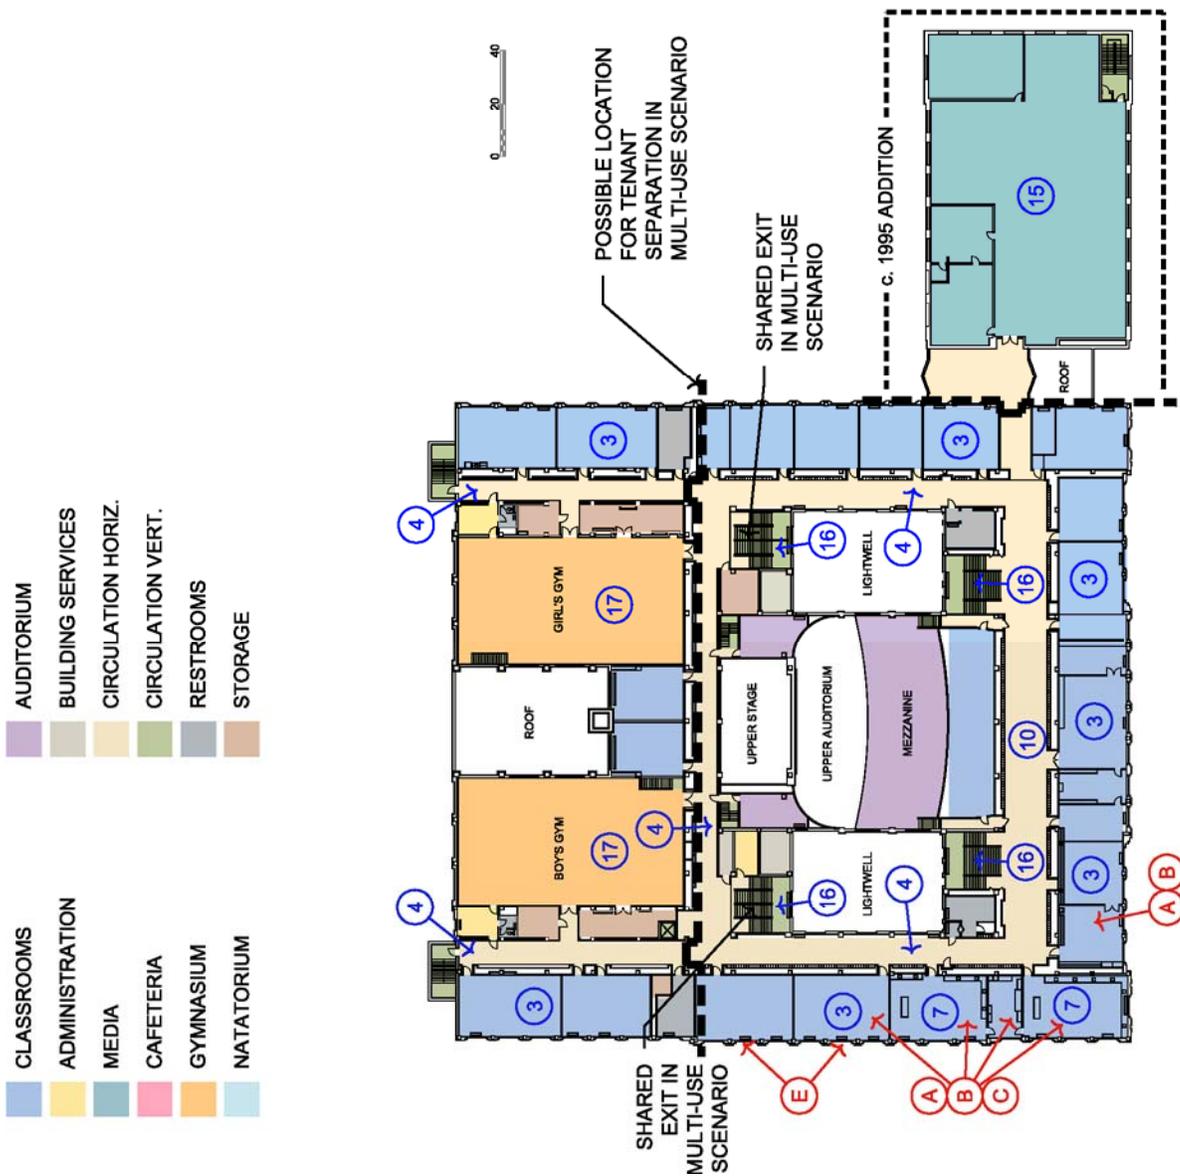
Second Floor

- CONDITION NOTES**
- A. Buckling wood flooring
 - B. Damaged lay-in ceiling tile
 - C. Water leak
 - D. Graffiti
 - E. Damaged window sash

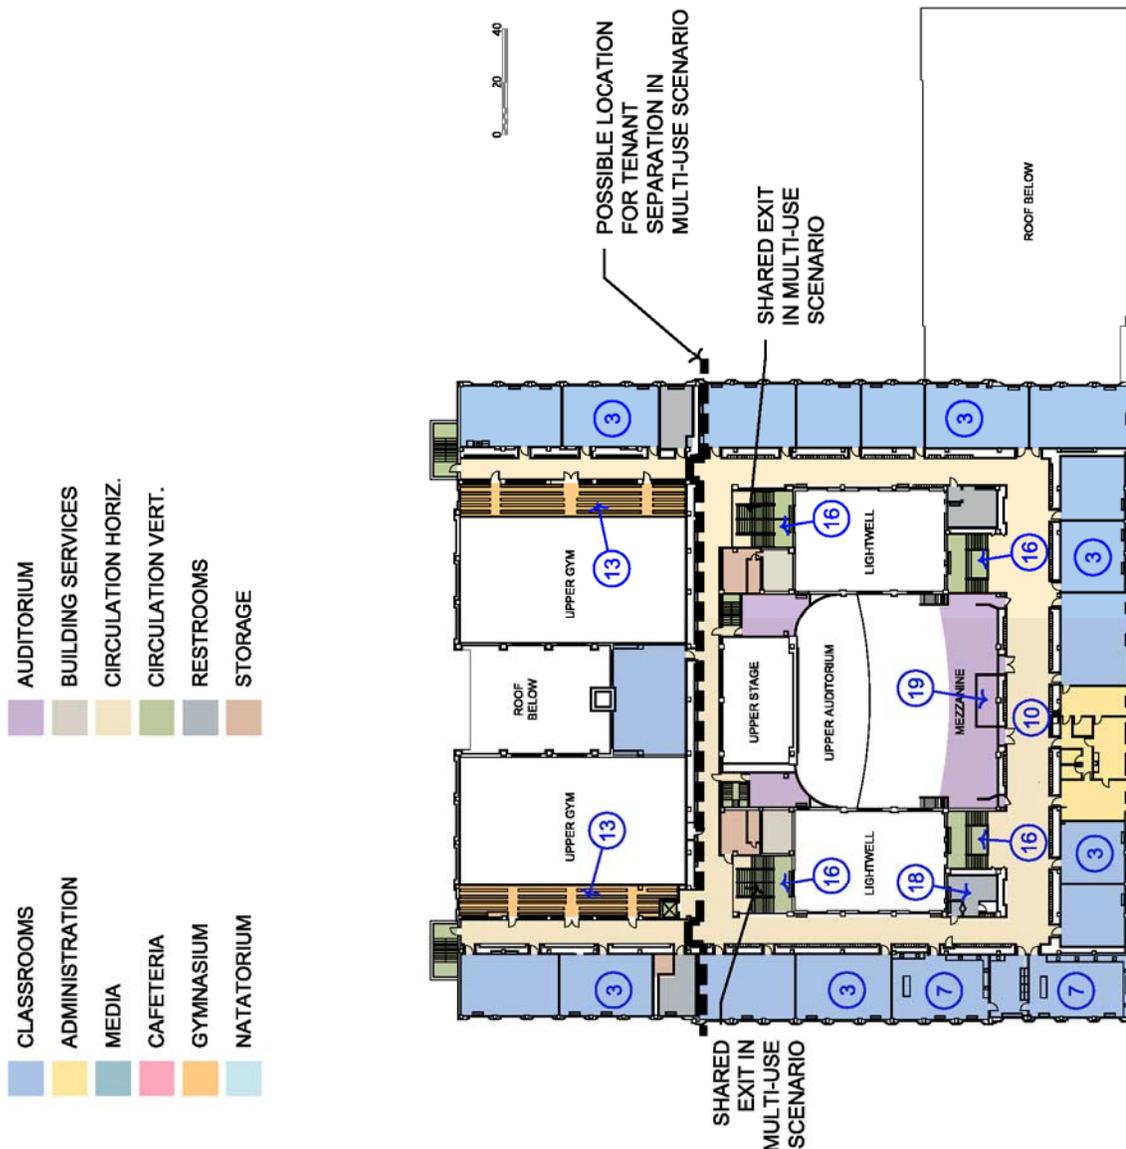
Third Floor

- A. Buckling wood flooring
- B. Damaged lay-in ceiling tile
- C. Water leak
- D. Graffiti
- E. Damaged window sash

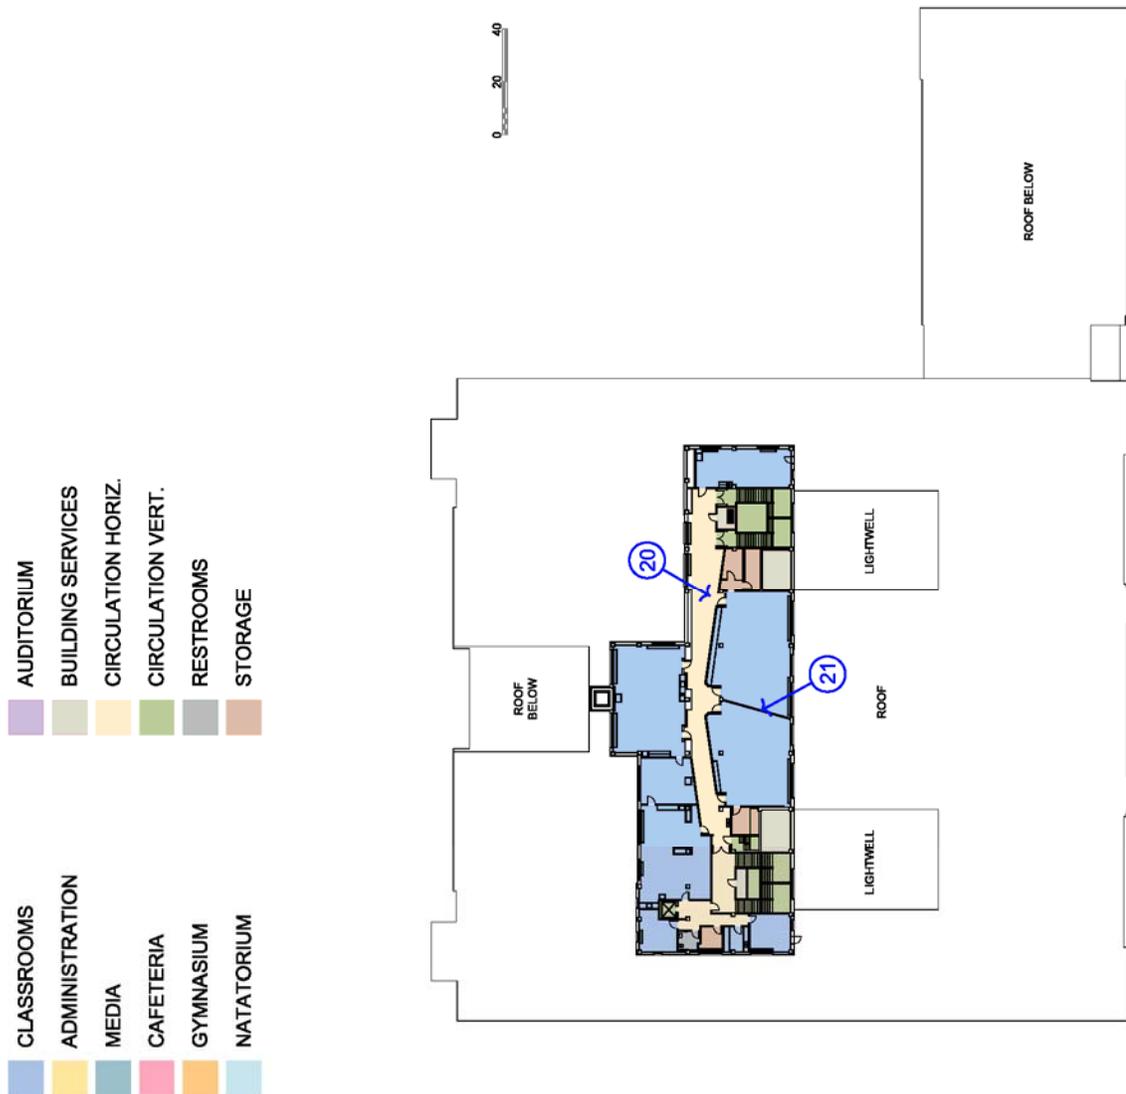
Fourth Floor

- A. Buckling wood flooring
- B. Damaged lay-in ceiling tile
- C. Water leak
- D. Graffiti
- E. Damaged window sash
