HAZARDOUS MATERIALS SURVEY REPORT

WESTPORT MIDDLE SCHOOL 300 EAST 39TH STREET KANSAS CITY, MISSOURI

April 13, 2011

Family Environmental, Inc.
COMPLIANCE SERVICES / SITE CLEARING SERVICES

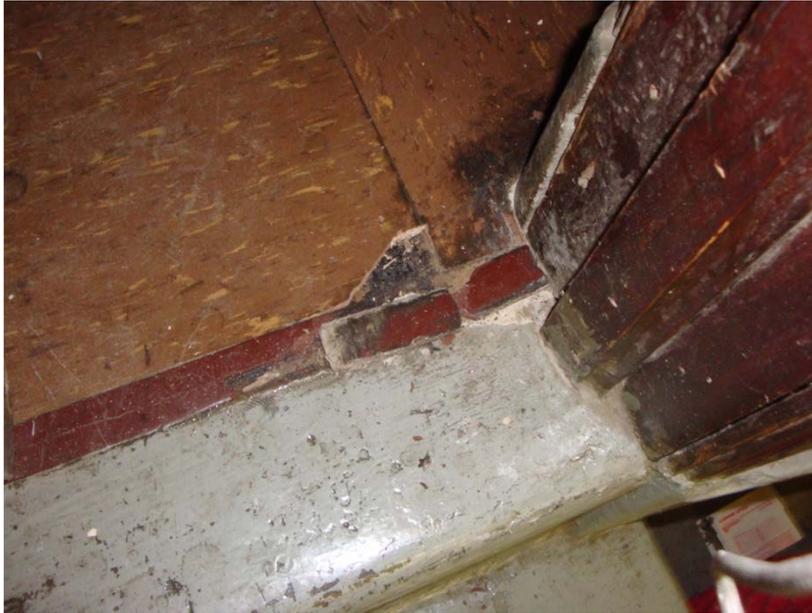
DIRECTION: North	DESCRIPTION	This photograph shows positive Brown with Tan Streaks 9x9 Floor Tile and Mastic in the Upper Custodian's Office.	1
	CLIENT	City of Kansas City Missouri	DATE
	PHOTOGRAPHER	Michael Dustman	03/04/11

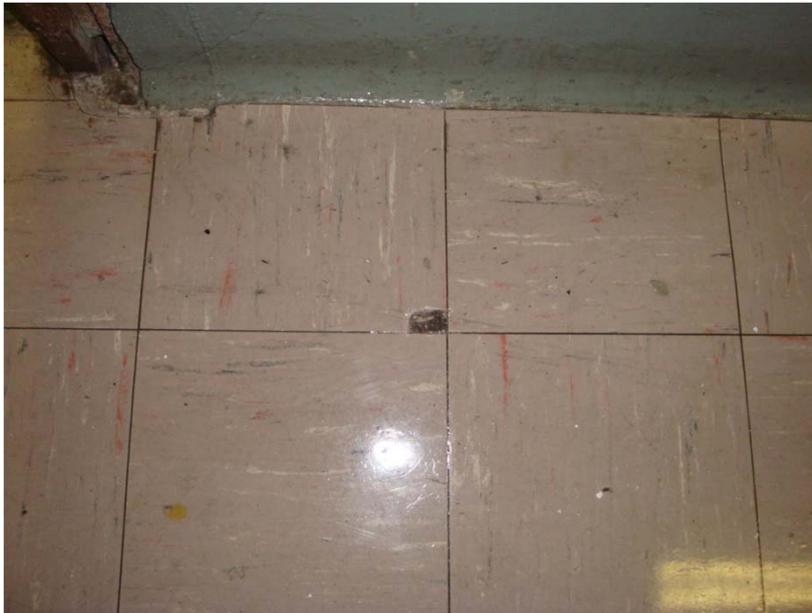
DIRECTION: North	DESCRIPTION	This photograph shows positive Grey with Red and White Streaks 9x9 Floor Tile and Mastic in Entrance to the Girl's Gym.	2
	CLIENT	City of Kansas City Missouri	DATE
	PHOTOGRAPHER	Michael Dustman	03/04/11

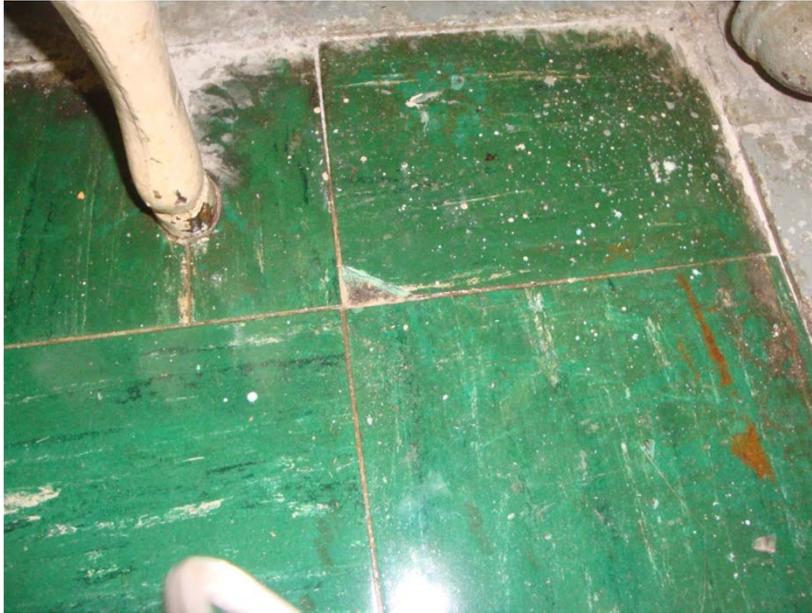
-
- Green with White and Black Streaks 9x9 Floor Tile and Mastic is located in the basement level P.E. Office. The floor tile contains 3% Chrysotile asbestos and the mastic contains 20% Chrysotile asbestos. Approximately 175 square feet of floor tile and mastic was observed in the same location in this building.

DIRECTION: North	DESCRIPTION	This photograph shows positive Green with White and Black Streaks 9x9 Floor Tile and Mastic in the P.E. Office.	3
	CLIENT	City of Kansas City Missouri	DATE
	PHOTOGRAPHER	Michael Dustman	03/04/11

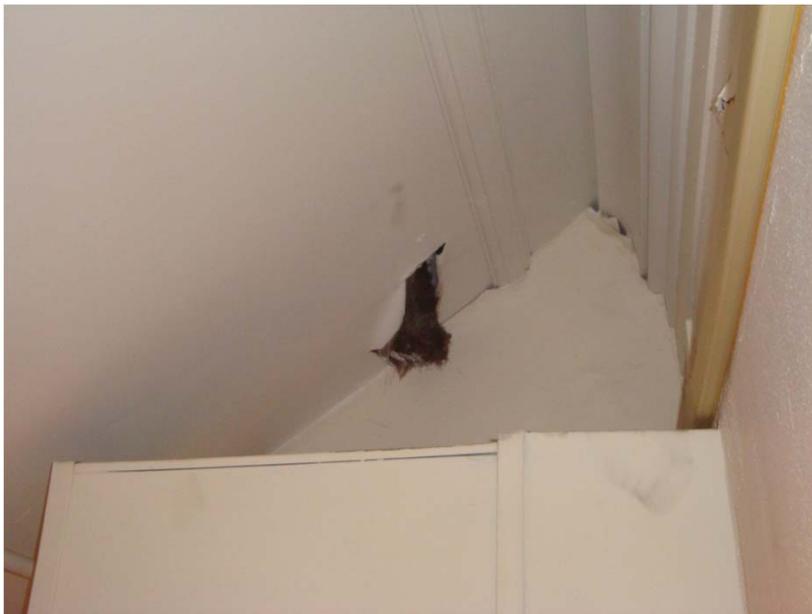
- Brown Insulation is located above a canvas ceiling in the sound booth area of the Auditorium. This insulation contains 40% Chrysotile asbestos. Approximately 600 square feet of insulation was observed in the same location in this building.

DIRECTION: East	DESCRIPTION	This photograph shows positive Brown Insulation above the auditorium Sound Booth Canvas Ceiling.	4
	CLIENT	City of Kansas City Missouri	DATE
	PHOTOGRAPHER	Michael Dustman	03/04/11

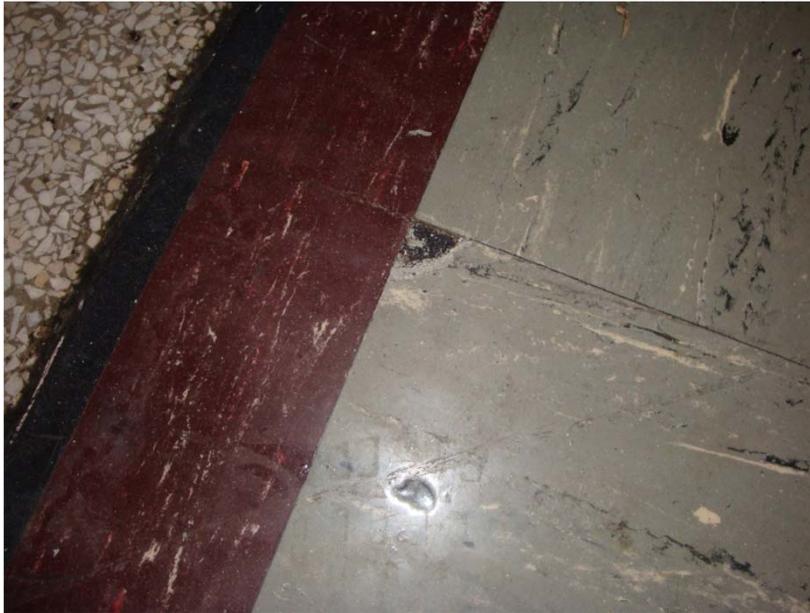
- Light Grey with White and Black Streaks 9x9 Floor Tile and Mastic is located in the south end of the 5th floor Cafeteria by the elevator. The floor tile contains 2% Chrysotile asbestos and the mastic contains 15% Chrysotile asbestos. Approximately 50 square feet of floor tile and mastic was observed in the same location in this building.

DIRECTION: West	DESCRIPTION	This photograph shows positive Light Grey with White and Black Streaks 9x9 Floor Tile and Mastic in SE Corner of the Cafeteria.	5
	CLIENT	City of Kansas City Missouri	DATE
	PHOTOGRAPHER	Michael Dustman	03/04/11

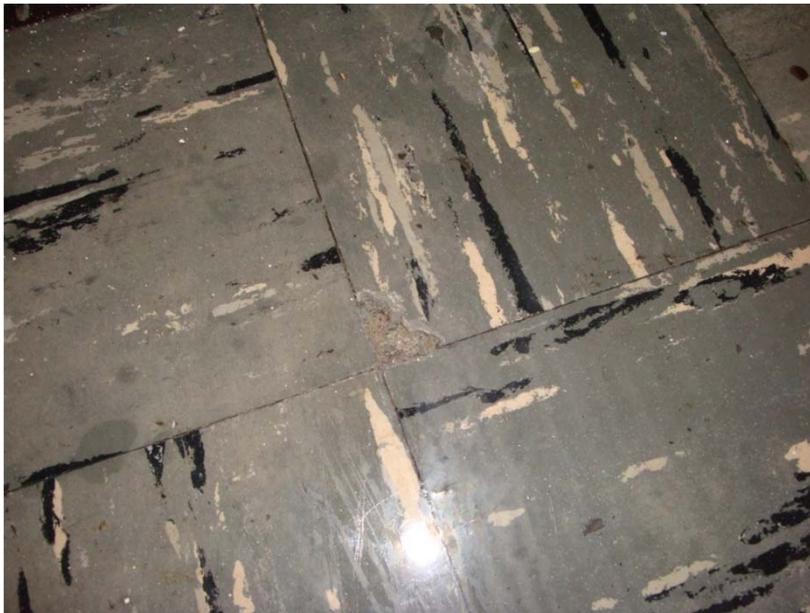
- Dark Grey with White and Black Streaks 9x9 Floor Tile and Mastic is located in the south end of the 5th floor Cafeteria by the elevator. The floor tile contains 5% Chrysotile asbestos and the mastic contains 10% Chrysotile asbestos. Approximately 50 square feet of floor tile and mastic was observed in the same location in this building.

DIRECTION: West	DESCRIPTION	This photograph shows positive Dark Grey with White and Black Streaks 9x9 Floor Tile and Mastic in SE Corner of the Cafeteria.	6
	CLIENT	City of Kansas City Missouri	DATE
	PHOTOGRAPHER	Michael Dustman	03/04/11

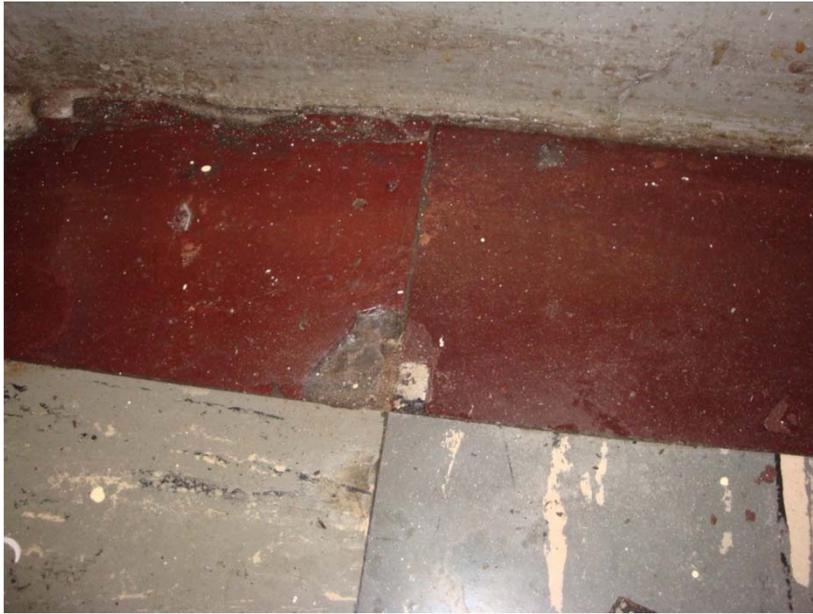
- Brown with Red and White Streaks 9x9 Floor Tile and Mastic is located in the south end of the 5th floor Cafeteria by the elevator. The floor tile contains 2% Chrysotile asbestos and the mastic contains 15% Chrysotile asbestos. Approximately 50 square feet of floor tile and mastic was observed in the same location in this building.

DIRECTION: North	DESCRIPTION	This photograph shows positive Brown with Red and White Streaks 9x9 Floor Tile and Mastic in the SE Corner of the Cafeteria.	7
	CLIENT	City of Kansas City Missouri	DATE
	PHOTOGRAPHER	Michael Dustman	03/04/11

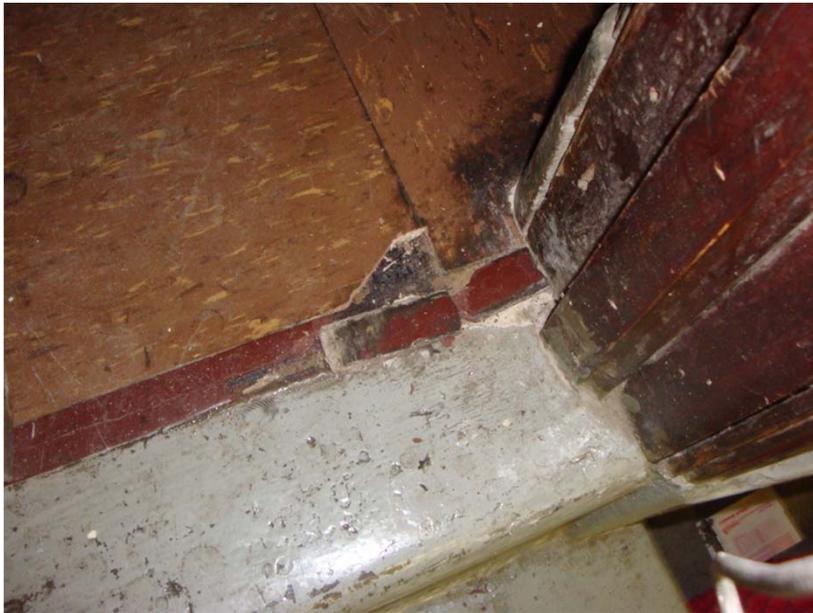
- Red/Brown Floor Tile Border and Mastic is located in the upper custodial break room area. The floor tile contains 2% Chrysotile asbestos and the mastic contains 10% Chrysotile asbestos. Approximately 130 square feet of floor tile and mastic was observed in the same location in this building.

DIRECTION: North	DESCRIPTION	This photograph shows positive Red Floor Tile border in the Upper Custodians Office.	8
	CLIENT	City of Kansas City Missouri	DATE
	PHOTOGRAPHER	Michael Dustman	03/04/11

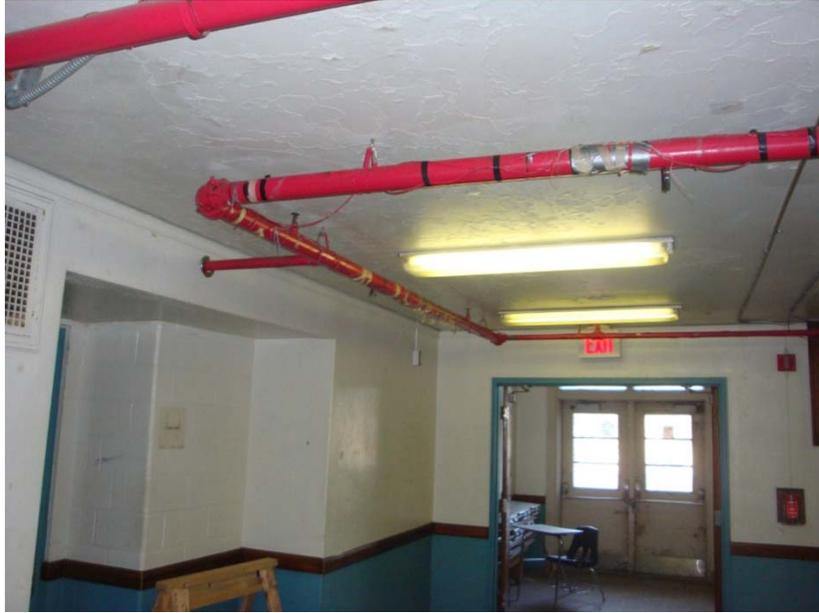
DIRECTION: East	DESCRIPTION	This photograph shows positive white paint on the ceiling outside the Boy's Locker Room, sample #12.	1
	CLIENT	City of Kansas City, Missouri	DATE
	PHOTOGRAPHER	Michael Dustman	03/11/11

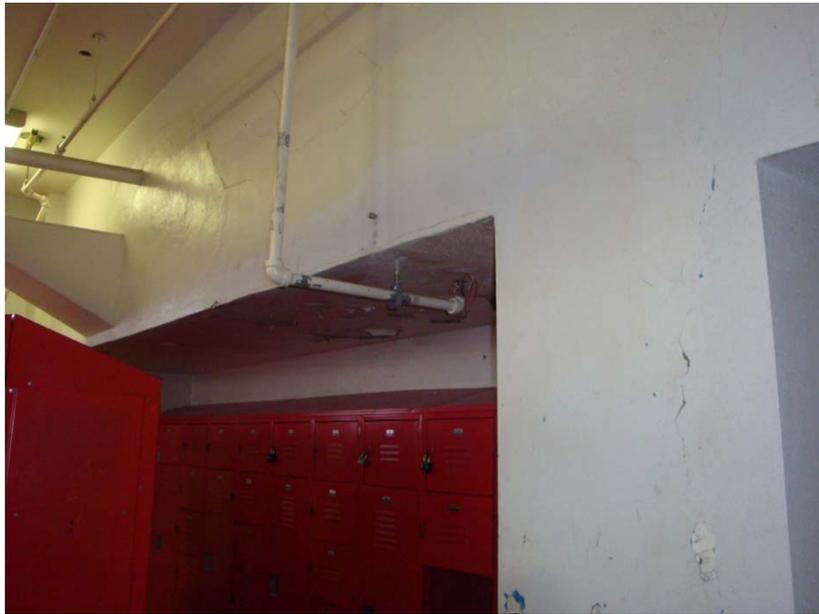
DIRECTION: East	DESCRIPTION	This photograph shows positive white paint on the wall and ceiling in the Boy's Locker Room, sample #13.	2
	CLIENT	City of Kansas City, Missouri	DATE
	PHOTOGRAPHER	Michael Dustman	03/11/11

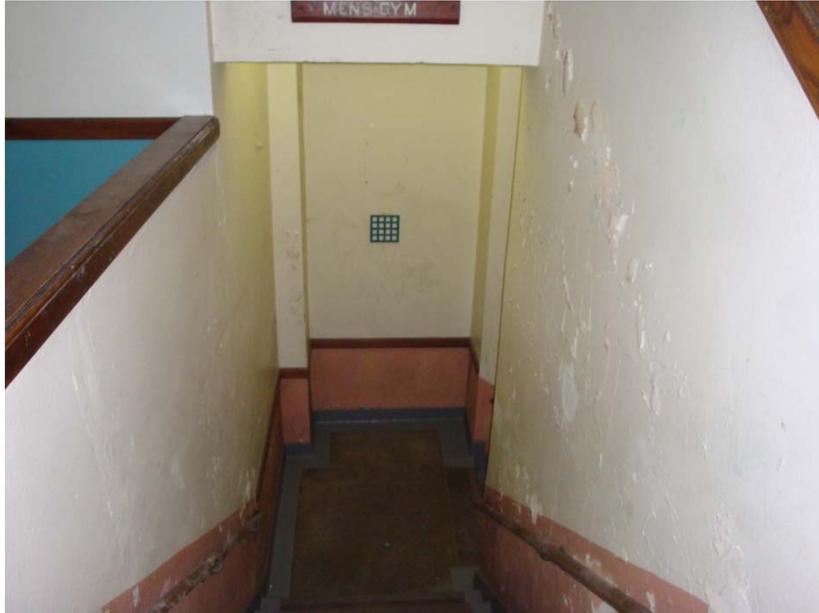
DIRECTION: South	DESCRIPTION	This photograph shows positive white and pink paint in the stairwell to the lower gym, sample #16 and #17.	3
	CLIENT	City of Kansas City, Missouri	DATE
	PHOTOGRAPHER	Michael Dustman	03/11/11

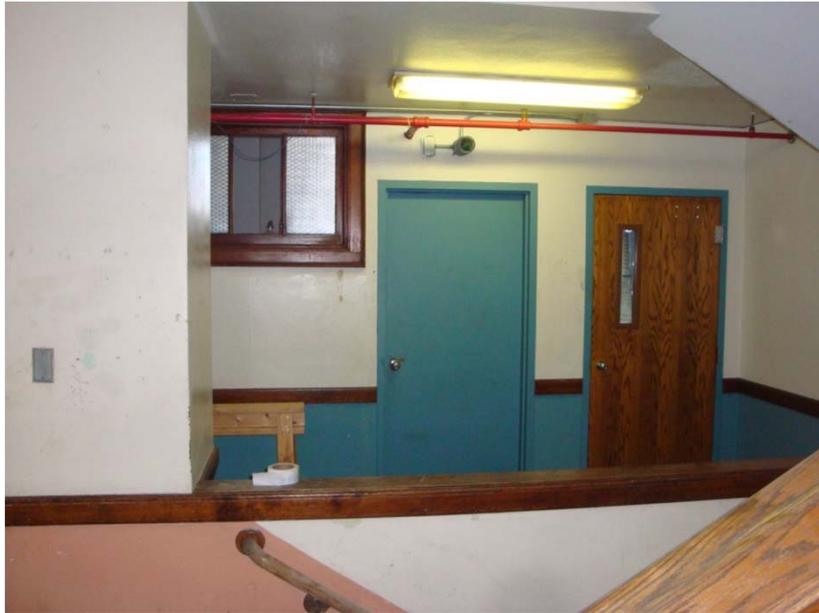
DIRECTION: East	DESCRIPTION	This photograph shows positive white paint between the two offices, sample #18.	4
	CLIENT	City of Kansas City, Missouri	DATE
	PHOTOGRAPHER	Michael Dustman	03/11/11

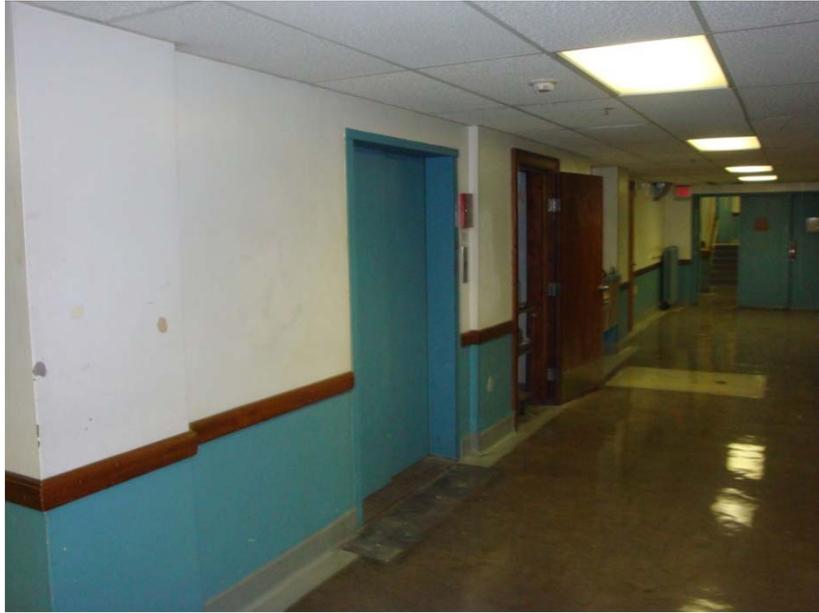
DIRECTION: Northeast	DESCRIPTION	This photograph shows positive white paint by the SW elevator, sample #20.	5
	CLIENT	City of Kansas City, Missouri	DATE
	PHOTOGRAPHER	Michael Dustman	03/11/11

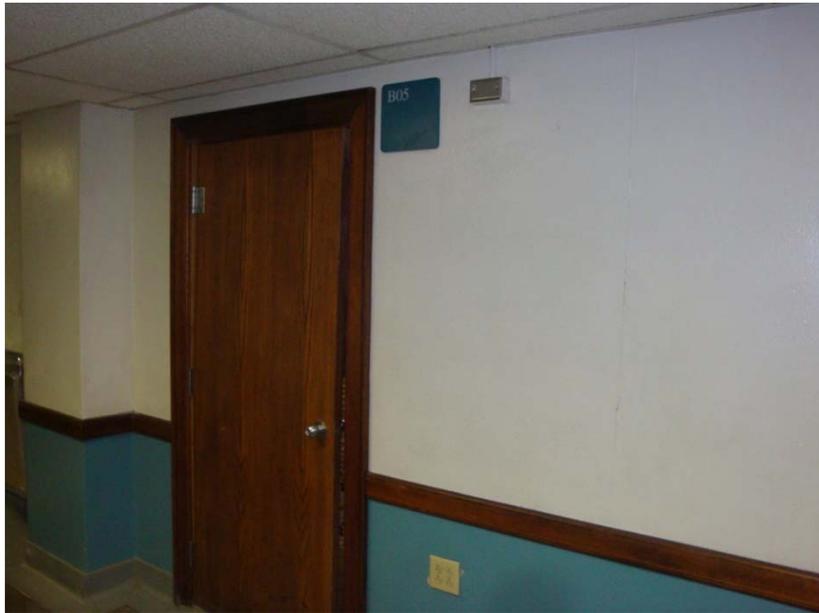
DIRECTION: Northwest	DESCRIPTION	This photograph shows positive white paint outside Room B05, sample #22.	6
	CLIENT	City of Kansas City, Missouri	DATE
	PHOTOGRAPHER	Michael Dustman	03/11/11

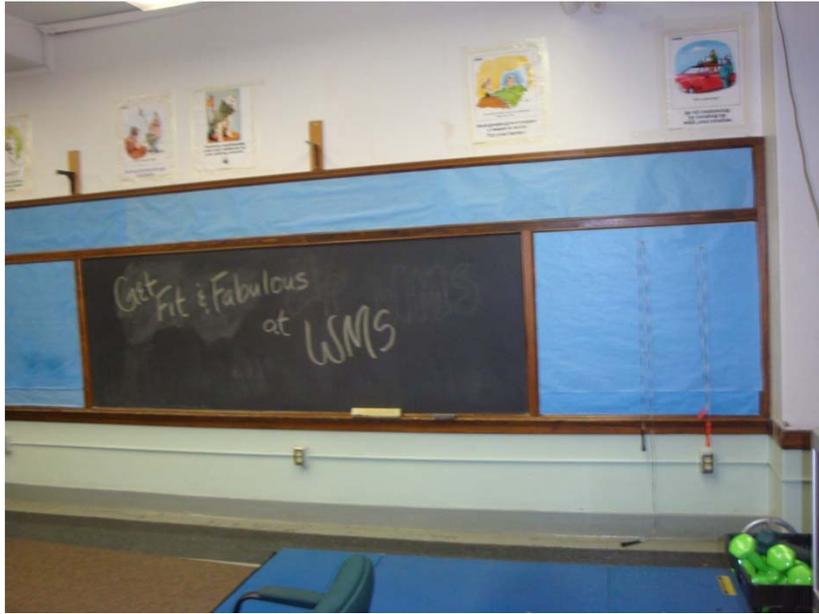
DIRECTION: East	DESCRIPTION	This photograph shows positive white and green paint in Room B04, sample # 28 and #29.	7
	CLIENT	City of Kansas City, Missouri	DATE
	PHOTOGRAPHER	Michael Dustman	02/22/11

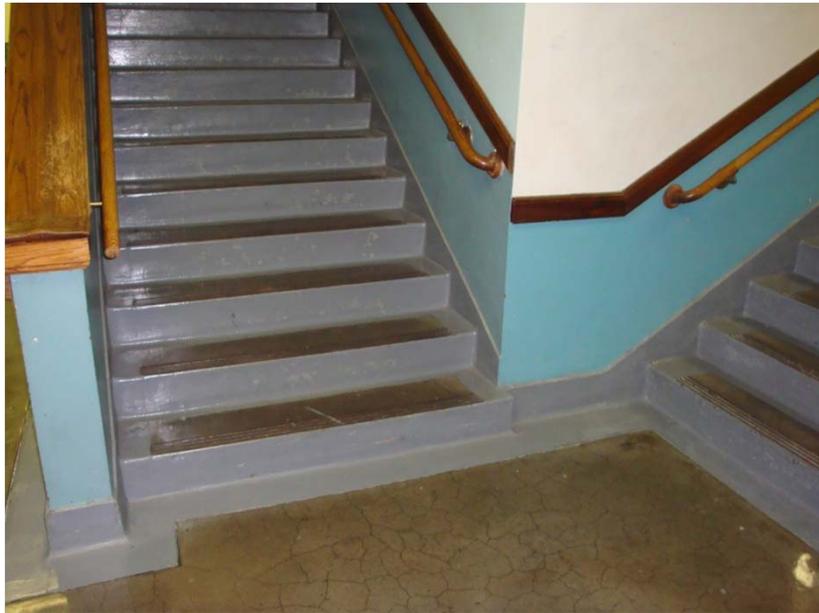
DIRECTION: North	DESCRIPTION	This photograph shows positive grey stair paint, sample #30.	8
	CLIENT	City of Kansas City, Missouri	DATE
	PHOTOGRAPHER	Michael Dustman	03/11/11

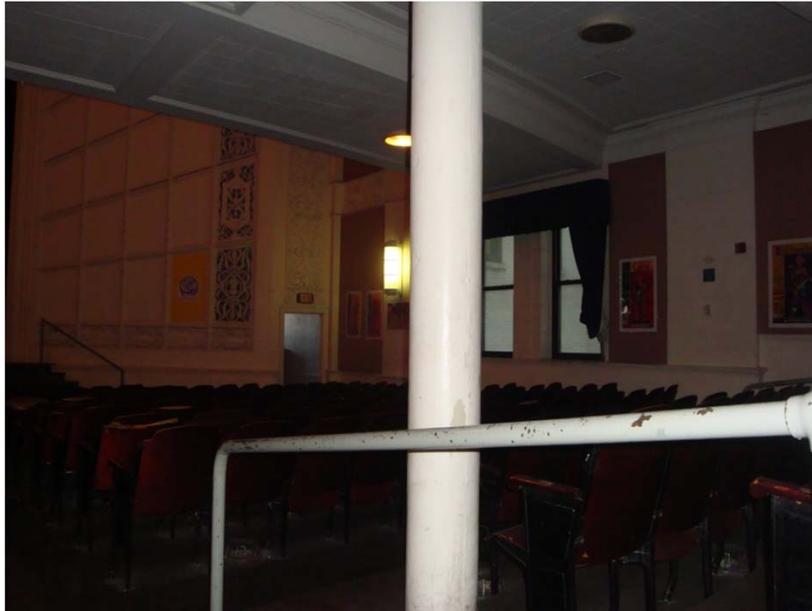
DIRECTION: Southeast	DESCRIPTION	This photograph shows positive white paint on a column in the auditorium, sample #32 and #36.	9
	CLIENT	City of Kansas City, Missouri	DATE
	PHOTOGRAPHER	Michael Dustman	03/11/11

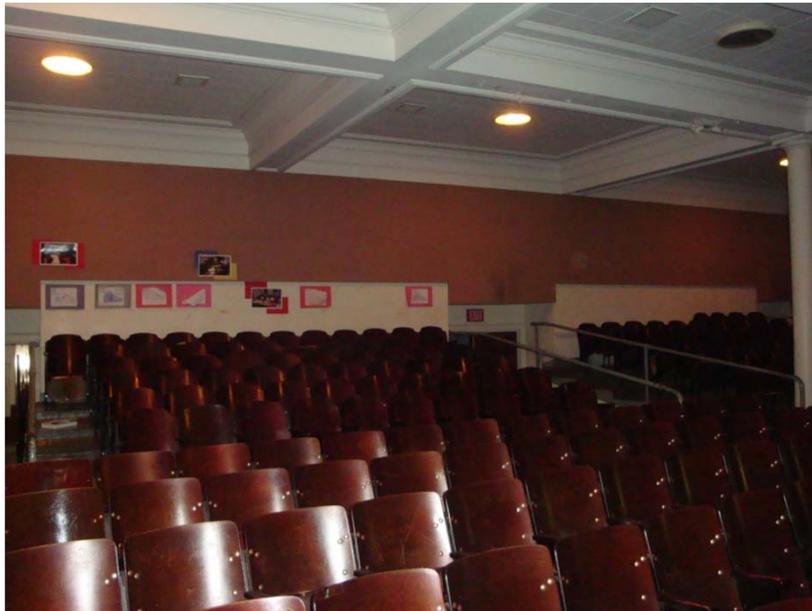
DIRECTION: West	DESCRIPTION	This photograph shows positive white paint on the west all in the auditorium, sample #34.	10
	CLIENT	City of Kansas City, Missouri	DATE
	PHOTOGRAPHER	Michael Dustman	03/11/11

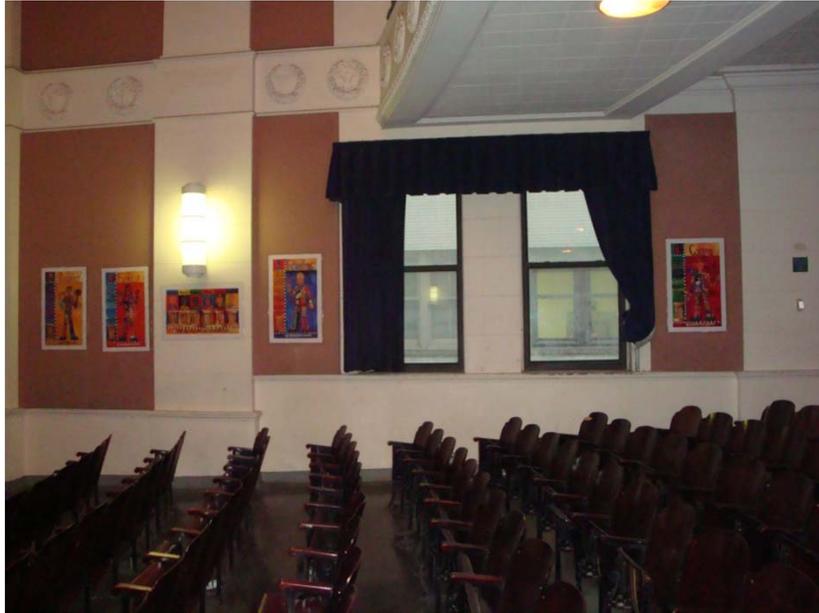
DIRECTION: South	DESCRIPTION	This photograph shows positive white paint on the south wall of the auditorium, sample #37.	11
	CLIENT	City of Kansas City, Missouri	DATE
	PHOTOGRAPHER	Michael Dustman	03/11/11

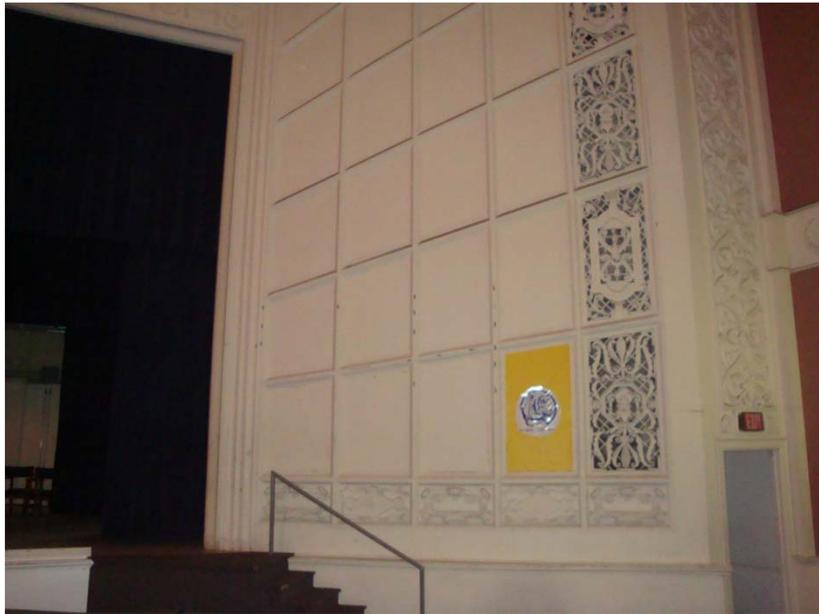
DIRECTION: Southeast	DESCRIPTION	This photograph shows positive white paint on the SE exit door frame and decorative plaster, sample #39 and #41.	12
	CLIENT	City of Kansas City, Missouri	DATE
	PHOTOGRAPHER	Michael Dustman	03/11/11

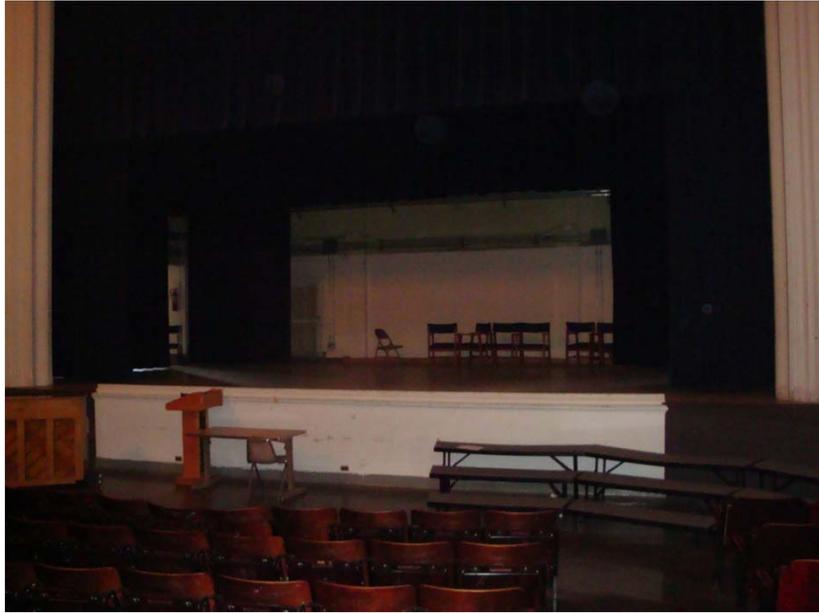
DIRECTION: East	DESCRIPTION	This photograph shows positive white paint on the east backstage wall and the front of the stage, sample #42 , #44, and #45.	13
	CLIENT	City of Kansas City, Missouri	DATE
	PHOTOGRAPHER	Michael Dustman	03/11/11

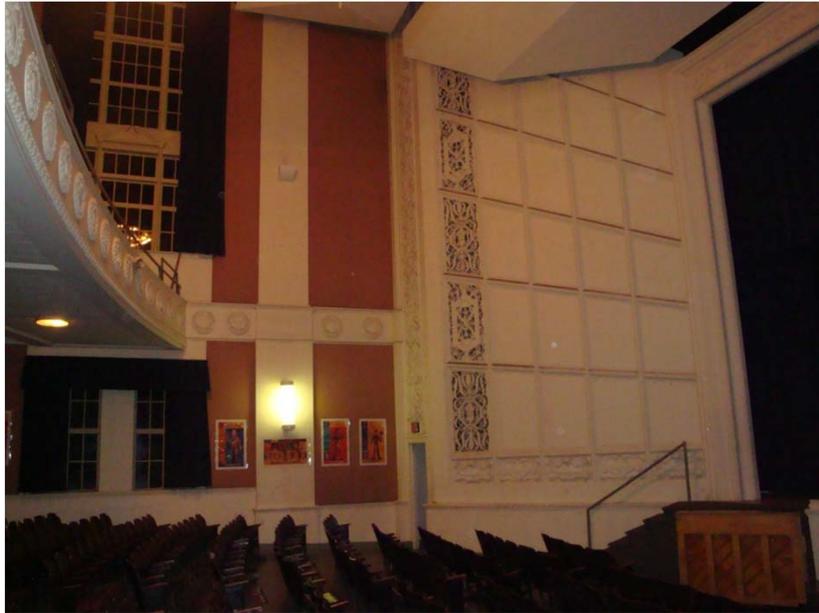
DIRECTION: North	DESCRIPTION	This photograph shows positive white paint on the NE auditorium wall, sample #43.	14
	CLIENT	City of Kansas City, Missouri	DATE
	PHOTOGRAPHER	Michael Dustman	03/11/11

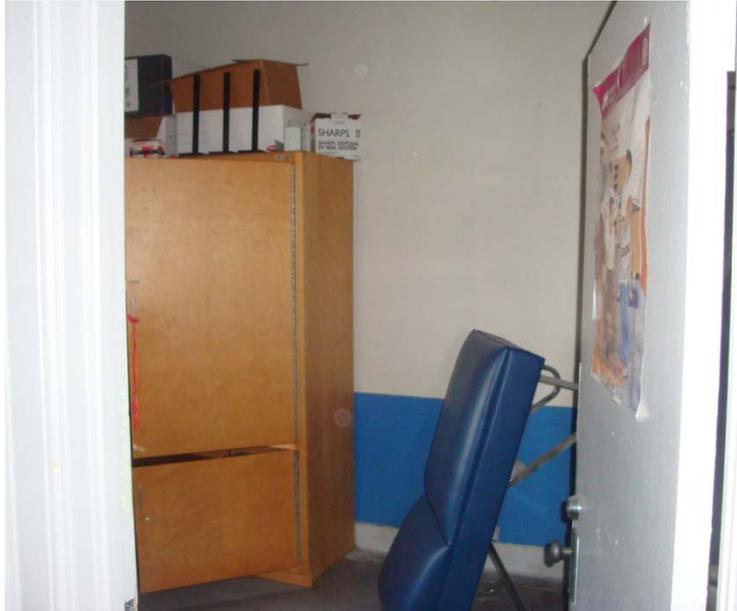
DIRECTION: South	DESCRIPTION	This photograph shows positive white and blue paint on the south wall of the Nurse's office, sample #46 and #47.	15
	CLIENT	City of Kansas City, Missouri	DATE
	PHOTOGRAPHER	Michael Dustman	03/11/11

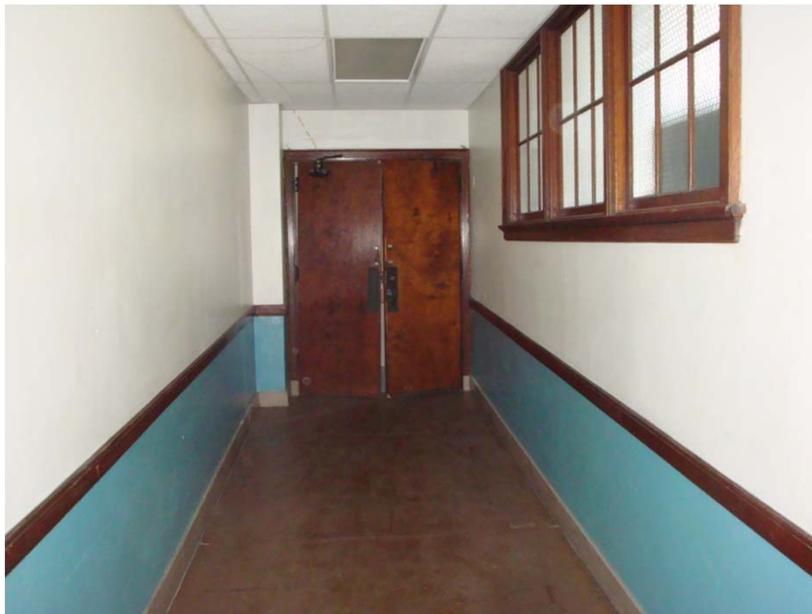
DIRECTION: North	DESCRIPTION	This photograph shows positive white and blue paint outside the Nurse's Office, sample #50 and #51.	16
	CLIENT	City of Kansas City, Missouri	DATE
	PHOTOGRAPHER	Michael Dustman	03/11/11

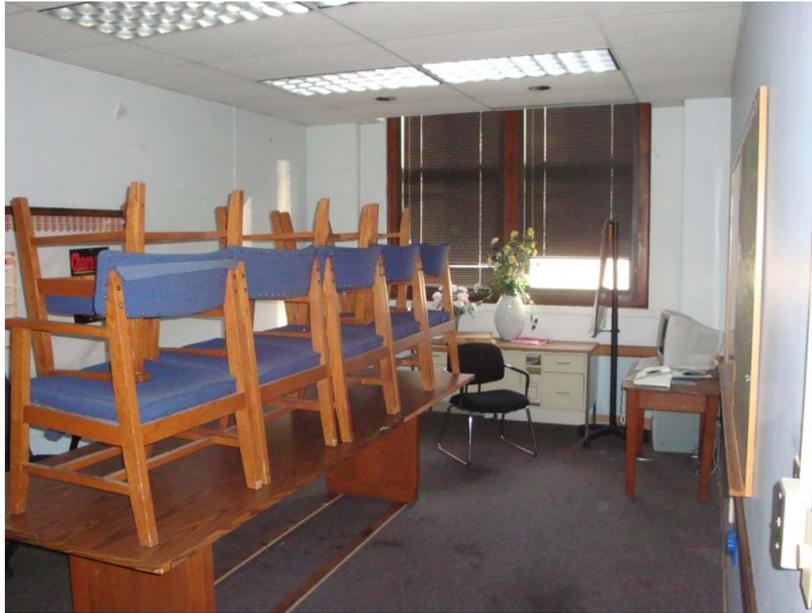
DIRECTION: South	DESCRIPTION	This photograph shows positive white and blue paint in the large conference room, sample #53, #54, #55, #56.	17
	CLIENT	City of Kansas City, Missouri	DATE
	PHOTOGRAPHER	Michael Dustman	03/11/11

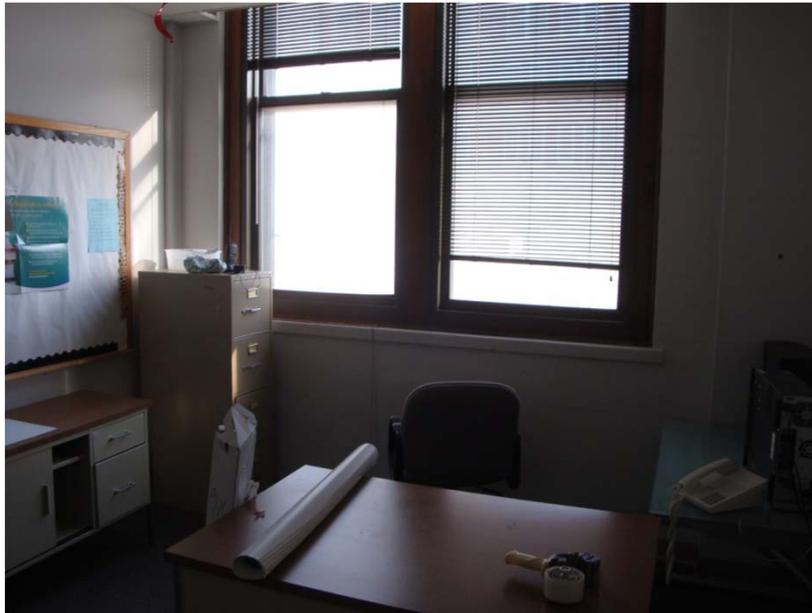
DIRECTION: South	DESCRIPTION	This photograph shows positive white paint on the south wall in the athletic director's office, sample #62.	18
	CLIENT	City of Kansas City, Missouri	DATE
	PHOTOGRAPHER	Michael Dustman	03/11/11

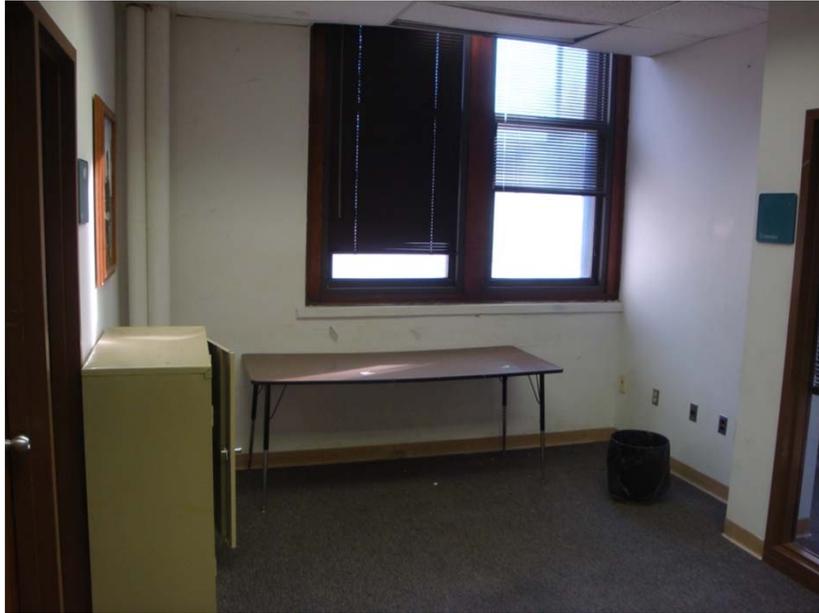
DIRECTION: South	DESCRIPTION	This photograph shows positive white paint on the SW corner of the admin office hallway, sample #66.	19
	CLIENT	City of Kansas City, Missouri	DATE
	PHOTOGRAPHER	Michael Dustman	03/11/11

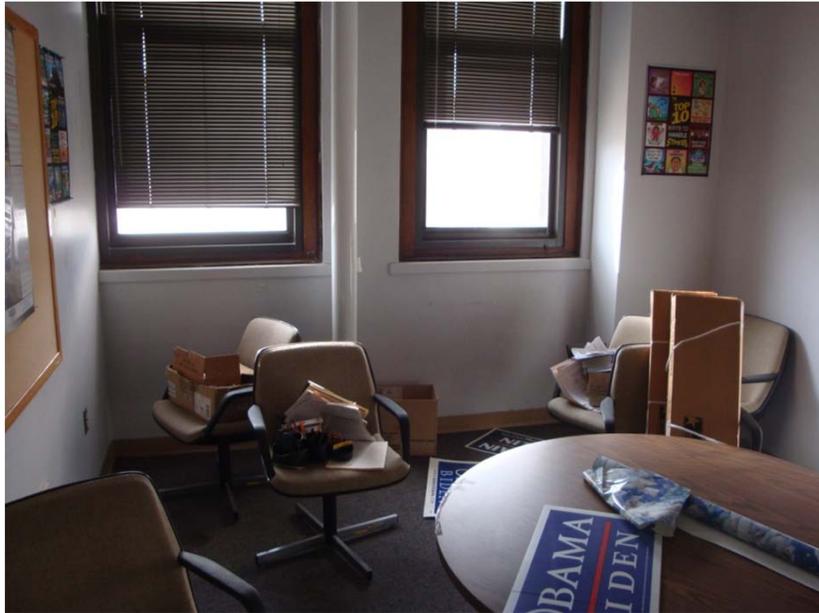
DIRECTION: West	DESCRIPTION	This photograph shows positive white paint on the west wall of the small conference room, sample #67.	20
	CLIENT	City of Kansas City, Missouri	DATE
	PHOTOGRAPHER	Michael Dustman	03/11/11

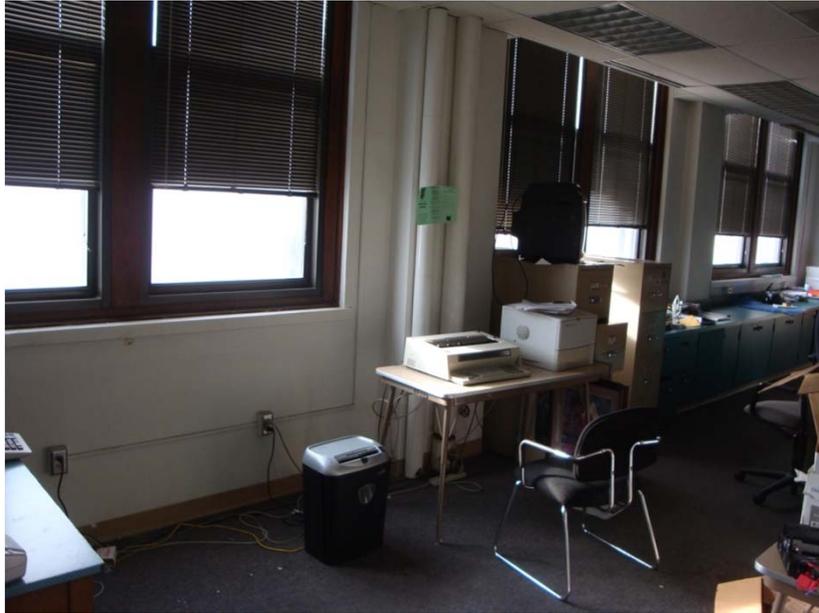
DIRECTION: West	DESCRIPTION	This photograph shows positive white paint in the office reception area, sample #71.	21
	CLIENT	City of Kansas City, Missouri	DATE
	PHOTOGRAPHER	Michael Dustman	03/11/11

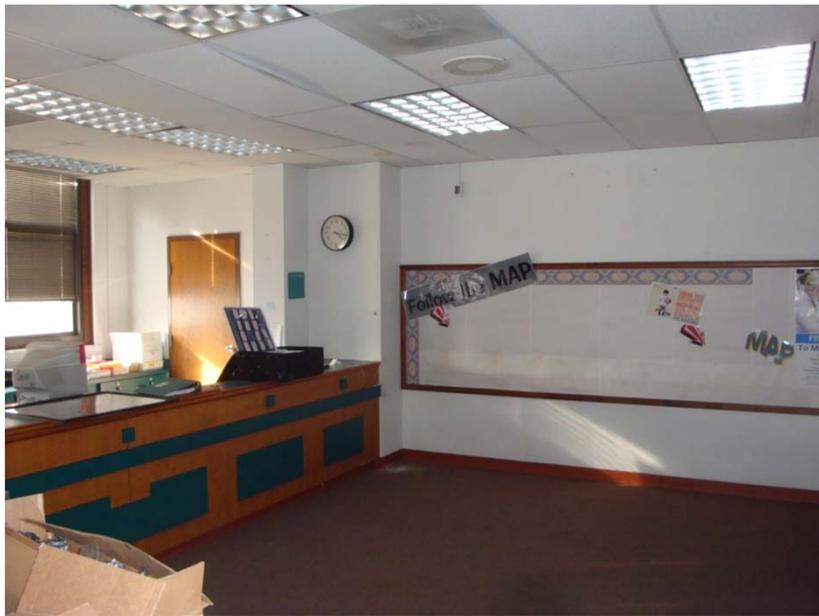
DIRECTION: Northwest	DESCRIPTION	This photograph shows positive white paint on the north wall of the office reception area, sample #72.	22
	CLIENT	City of Kansas City, Missouri	DATE
	PHOTOGRAPHER	Michael Dustman	03/11/11

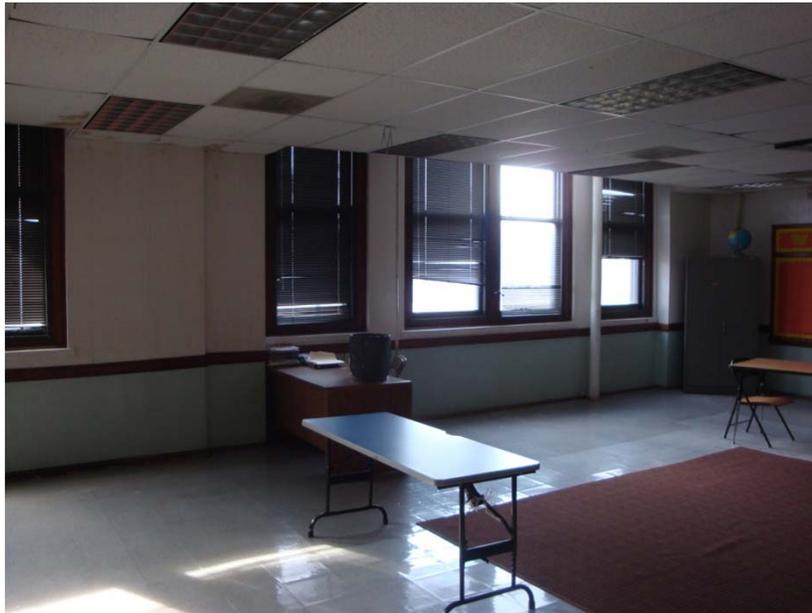
DIRECTION: West	DESCRIPTION	This photograph shows positive white paint on the west wall of Room 104, sample #73 and #75.	23
	CLIENT	City of Kansas City, Missouri	DATE
	PHOTOGRAPHER	Michael Dustman	03/11/11

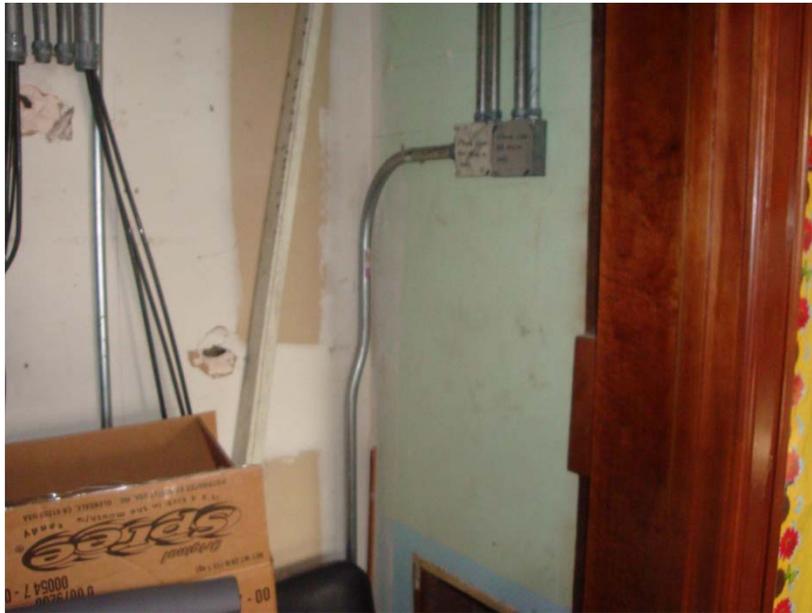
DIRECTION: Southeast	DESCRIPTION	This photograph shows positive green paint on a closet wall in Room 104, sample #76.	24
	CLIENT	City of Kansas City, Missouri	DATE
	PHOTOGRAPHER	Michael Dustman	03/11/11

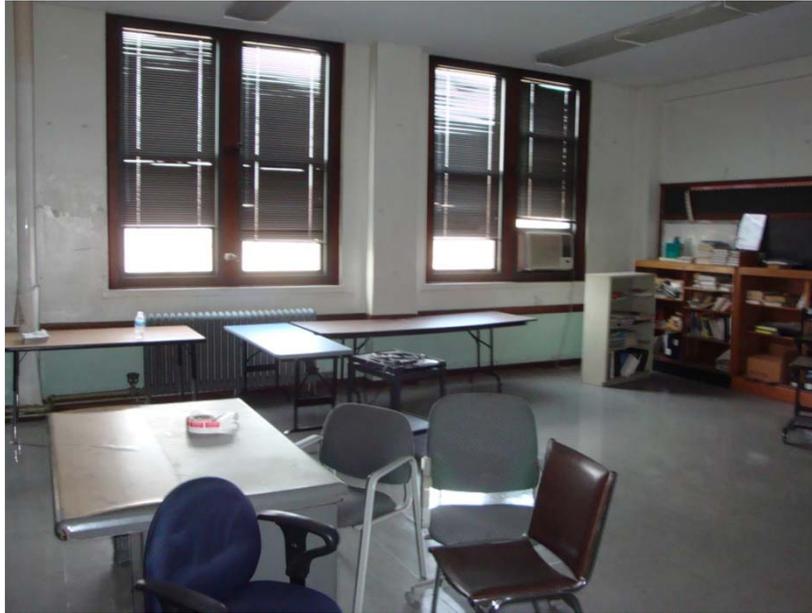
DIRECTION: North	DESCRIPTION	This photograph shows positive white and blue paint on the north wall of Room 102, sample #77 and #78.	25
	CLIENT	City of Kansas City, Missouri	DATE
	PHOTOGRAPHER	Michael Dustman	03/11/11

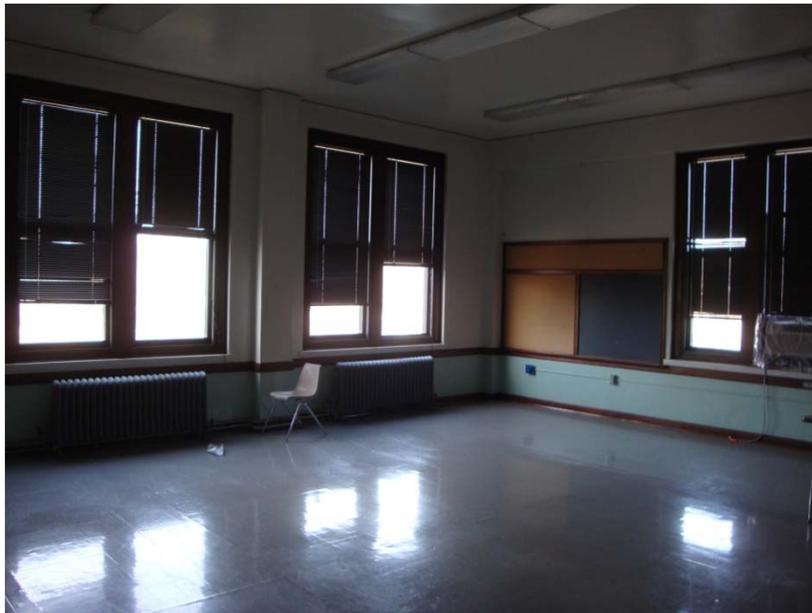
DIRECTION: South	DESCRIPTION	This photograph shows positive white and blue paint on the east wall of Room 101, sample #80 and #81.	26
	CLIENT	City of Kansas City, Missouri	DATE
	PHOTOGRAPHER	Michael Dustman	03/11/11

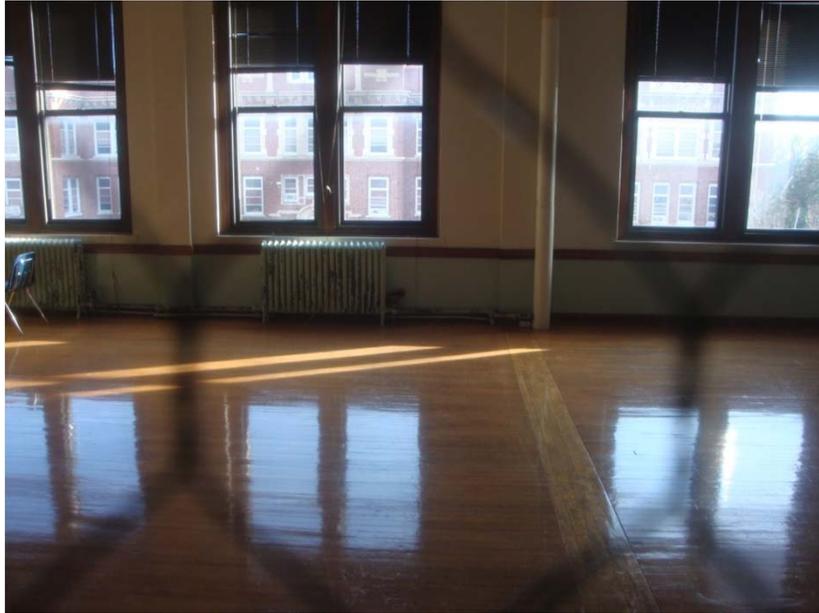
DIRECTION: Southwest	DESCRIPTION	This photograph shows positive white and blue paint on the south wall of Room 411, sample #92 and #93.	27
	CLIENT	City of Kansas City, Missouri	DATE
	PHOTOGRAPHER	Michael Dustman	03/11/11

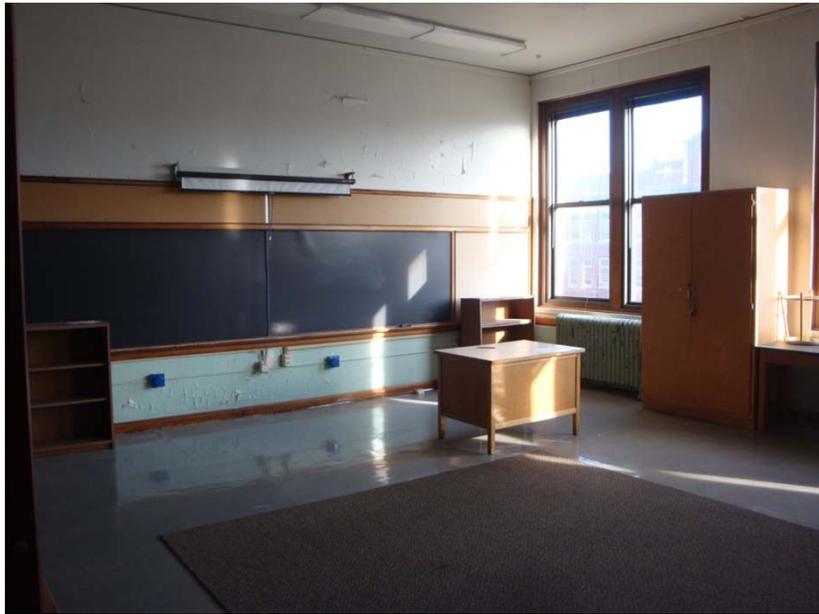
DIRECTION: Southwest	DESCRIPTION	This photograph shows positive white and blue paint on the south wall of Room 409, sample #95 and #96.	28
	CLIENT	City of Kansas City, Missouri	DATE
	PHOTOGRAPHER	Michael Dustman	03/11/11

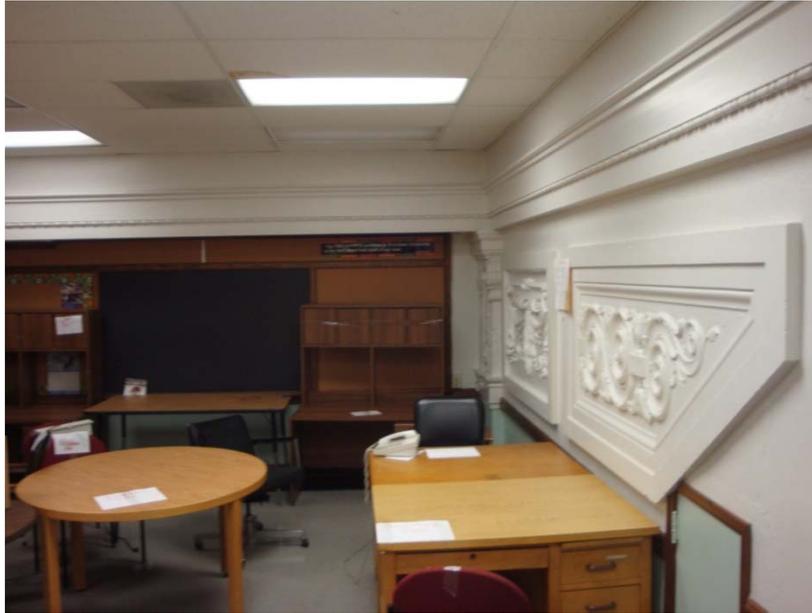
DIRECTION: East	DESCRIPTION	This photograph shows positive white and blue paint on the south wall of Room 417, sample #98 and #99.	29
	CLIENT	City of Kansas City, Missouri	DATE
	PHOTOGRAPHER	Michael Dustman	03/11/11

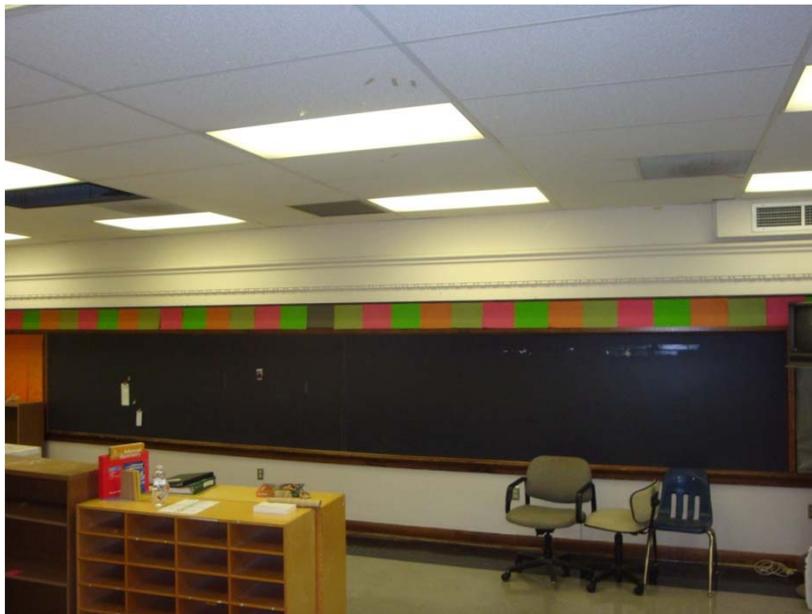
DIRECTION: East	DESCRIPTION	This photograph shows positive white paint on decorative plaster in Room 416, sample #100.	30
	CLIENT	City of Kansas City, Missouri	DATE
	PHOTOGRAPHER	Michael Dustman	03/11/11

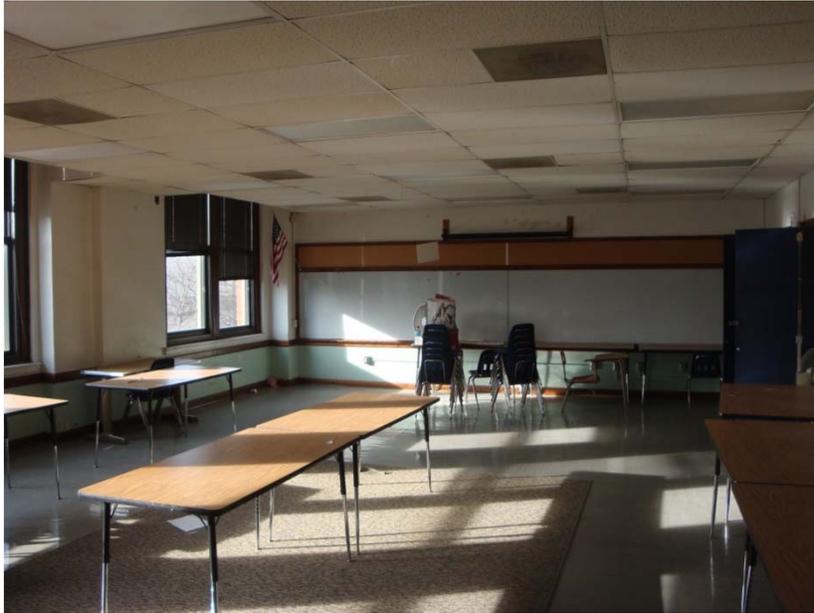
DIRECTION: Northwest	DESCRIPTION	This photograph shows positive white and blue paint on the west wall of Room 306, sample #101 and #102.	31
	CLIENT	City of Kansas City, Missouri	DATE
	PHOTOGRAPHER	Michael Dustman	03/11/11

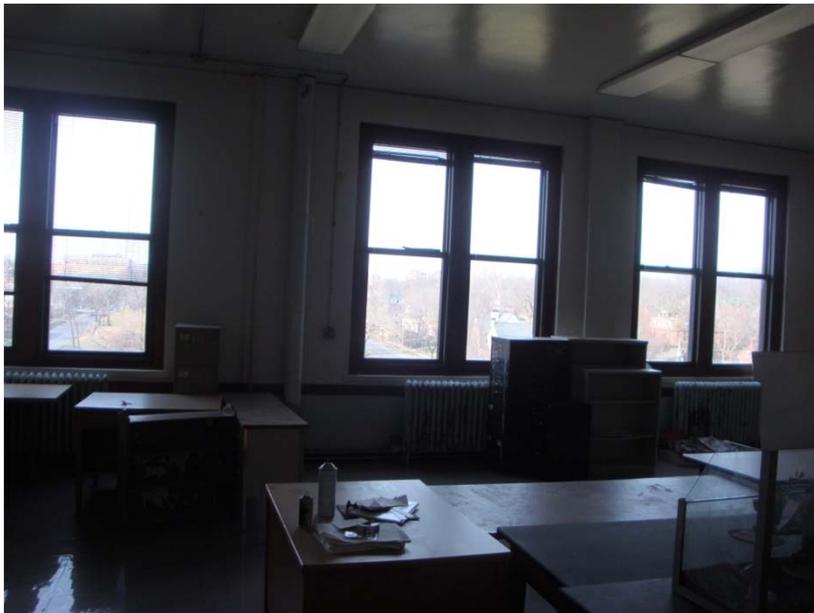
DIRECTION: East	DESCRIPTION	This photograph shows positive white and blue paint on the east wall of Room 309, sample #103 and #104.	32
	CLIENT	City of Kansas City, Missouri	DATE
	PHOTOGRAPHER	Michael Dustman	03/11/11
