HAZARDOUS MATERIALS SURVEY REPORT

WESTPORT MIDDLE SCHOOL 300 EAST 39TH STREET KANSAS CITY, MISSOURI

April 13, 2011

Family Environmental, Inc.
COMPLIANCE SERVICES / SITE CLEARING SERVICES

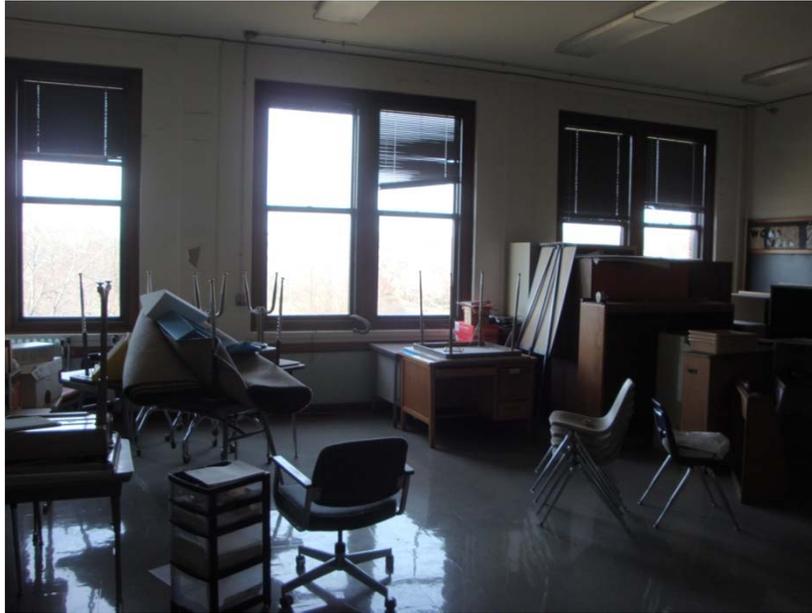
DIRECTION: West	DESCRIPTION	This photograph shows positive white and blue paint on the west wall of Room 303, sample #105 and #106.	33
	CLIENT	City of Kansas City, Missouri	DATE
	PHOTOGRAPHER	Michael Dustman	03/11/11

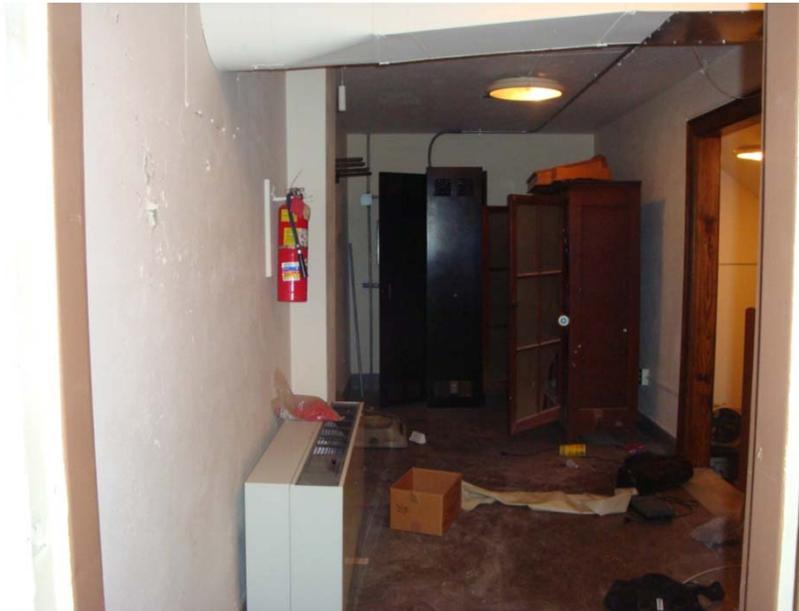
DIRECTION: Northwest	DESCRIPTION	This photograph shows positive white paint on the west wall of the sound booth, sample #107.	34
	CLIENT	City of Kansas City, Missouri	DATE
	PHOTOGRAPHER	Michael Dustman	03/11/11

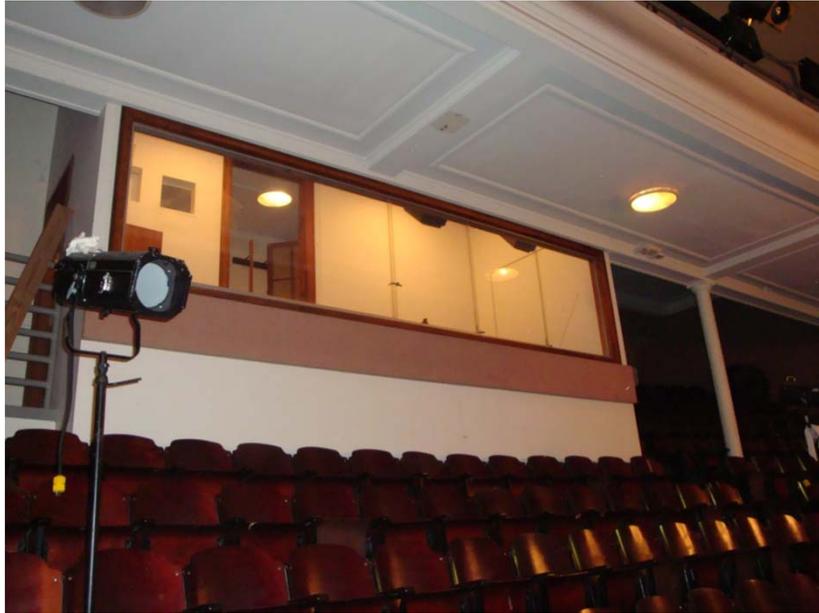
DIRECTION: West	DESCRIPTION	This photograph shows positive white paint on the exterior sound booth, sample #108.	35
	CLIENT	City of Kansas City, Missouri	DATE
	PHOTOGRAPHER	Michael Dustman	03/11/11

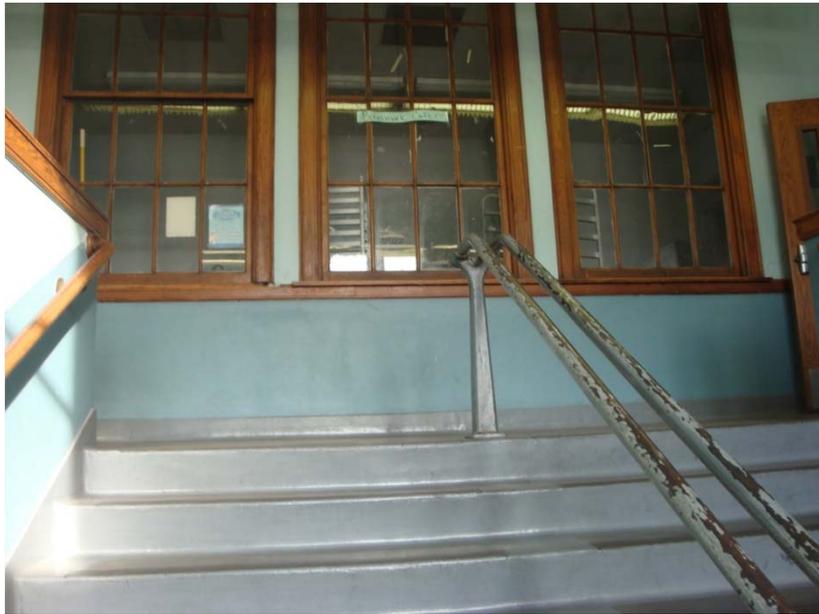
DIRECTION: South	DESCRIPTION	This photograph shows positive blue paint on the 5 th floor stair landing, sample #112.	36
	CLIENT	City of Kansas City, Missouri	DATE
	PHOTOGRAPHER	Michael Dustman	03/11/11

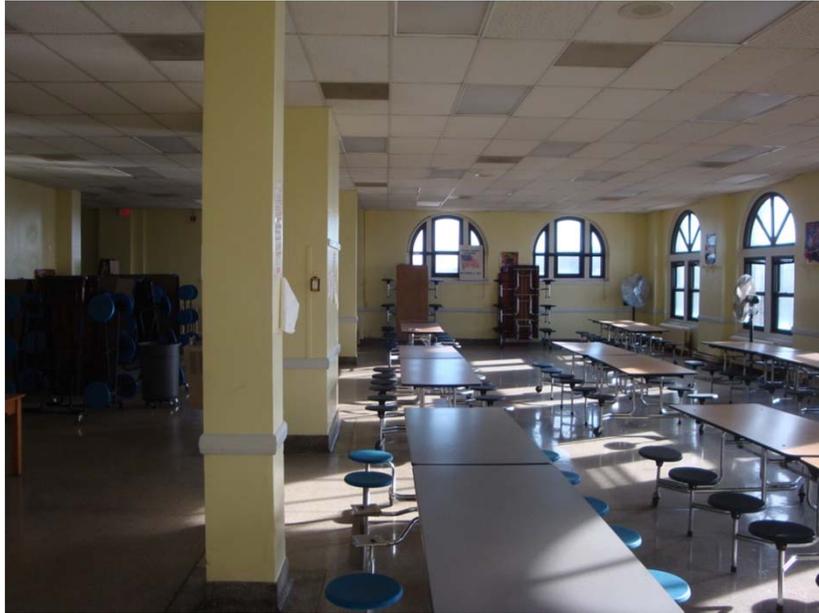
DIRECTION: Southwest	DESCRIPTION	This photograph shows positive yellow paint on the south and west walls of the cafeteria, sample #113 and #114.	37
	CLIENT	City of Kansas City, Missouri	DATE
	PHOTOGRAPHER	Michael Dustman	03/11/11

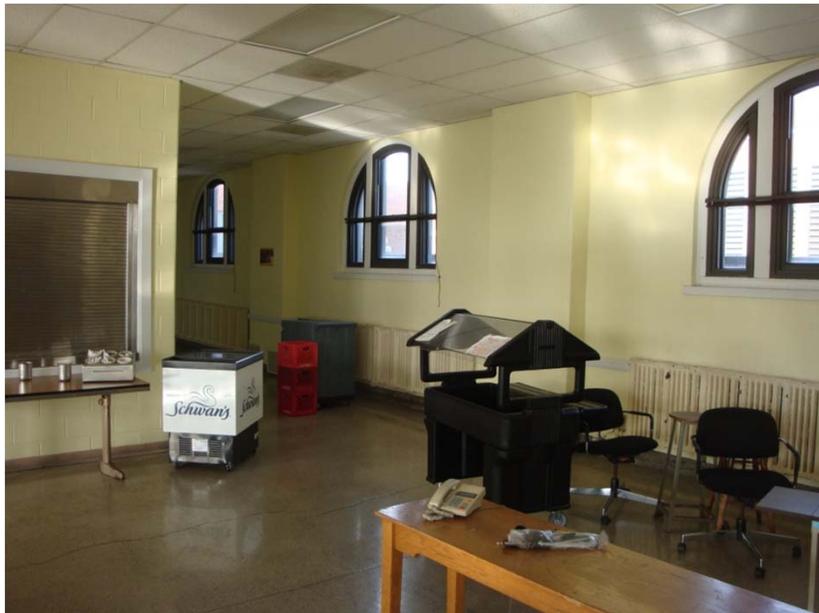
DIRECTION: Northeast	DESCRIPTION	This photograph shows positive yellow paint on the east wall of the cafeteria, sample #115.	38
	CLIENT	City of Kansas City, Missouri	DATE
	PHOTOGRAPHER	Michael Dustman	03/11/11

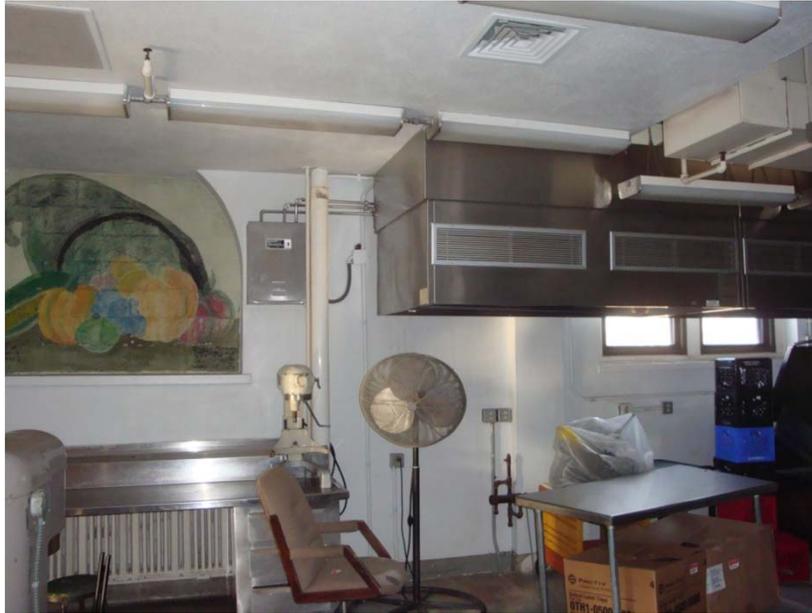
DIRECTION: North	DESCRIPTION	This photograph shows positive white paint on the north wall of the cafeteria kitchen, sample #116.	39
	CLIENT	City of Kansas City, Missouri	DATE
	PHOTOGRAPHER	Michael Dustman	03/11/11

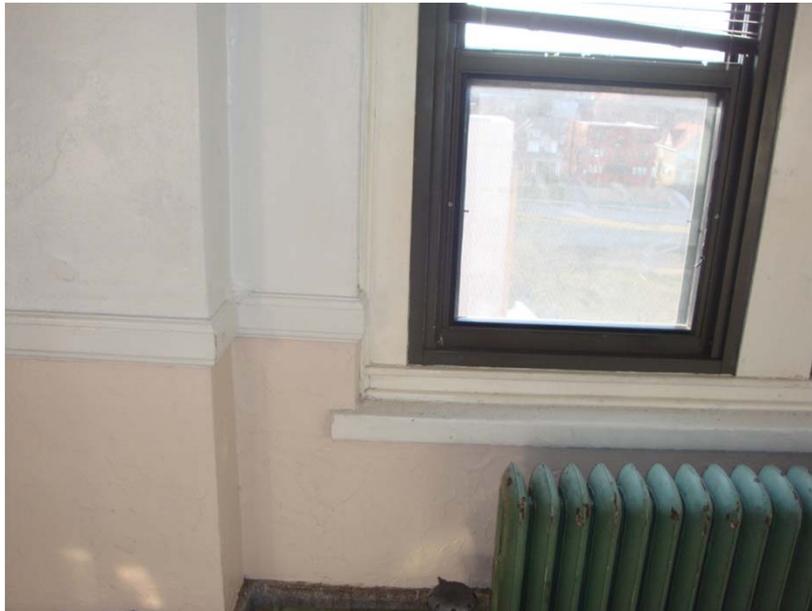
DIRECTION: South	DESCRIPTION	This photograph shows positive pink, white, and green paint in the south wall of the cafeteria kitchen, sample #117, #118 and #119.	40
	CLIENT	City of Kansas City, Missouri	DATE
	PHOTOGRAPHER	Michael Dustman	03/11/11

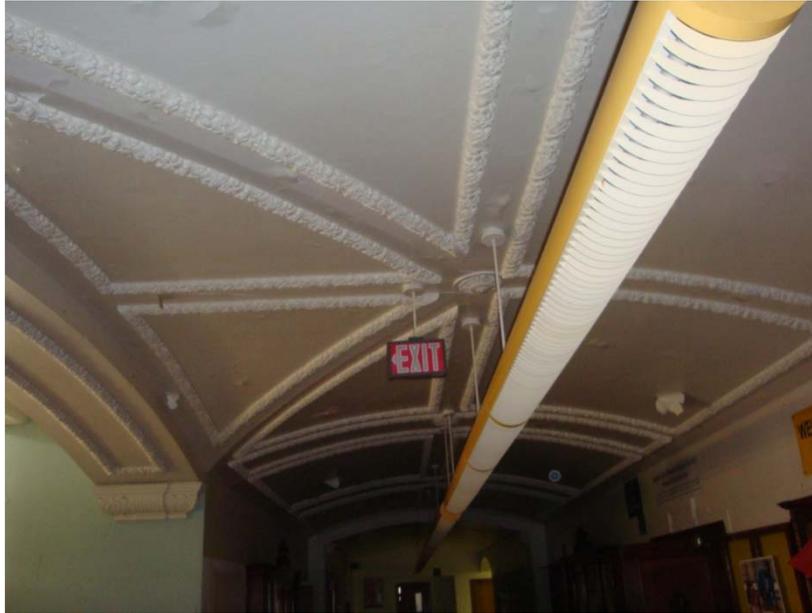
DIRECTION: North	DESCRIPTION	This photograph shows positive white decorative plaster on the first floor hall ceiling.	41
	CLIENT	City of Kansas City, Missouri	DATE
	PHOTOGRAPHER	Michael Dustman	03/11/11
