# Swinney

1106 West 47<sup>th</sup> Street

## REUSE ASSESSMENT

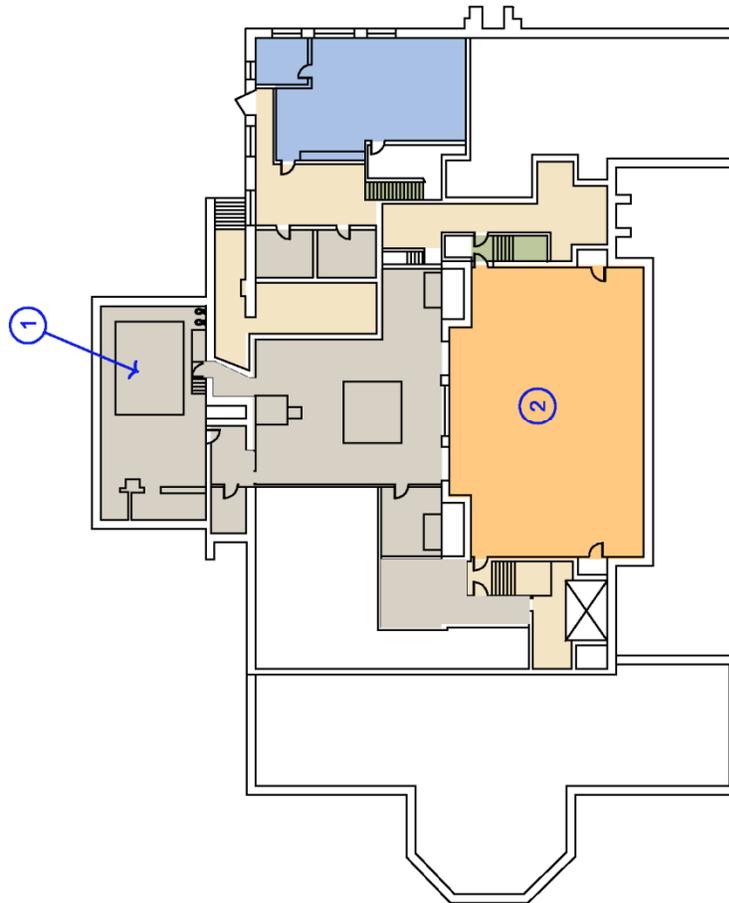
Basement

14. Enclosed "porch" has concrete columns and railings
- CONDITION NOTES**
- A. Water damage at wall and ceiling
  - B. Deteriorated steel lintel above window

THIS LEVEL COULD NOT BE DIVIDED FOR MULTIPLE USES UNLESS MORE EXITS ARE PROVIDED
