Ladd

3640 Benton Boulevard

Historical Brief

REUSE ASSESSMENT

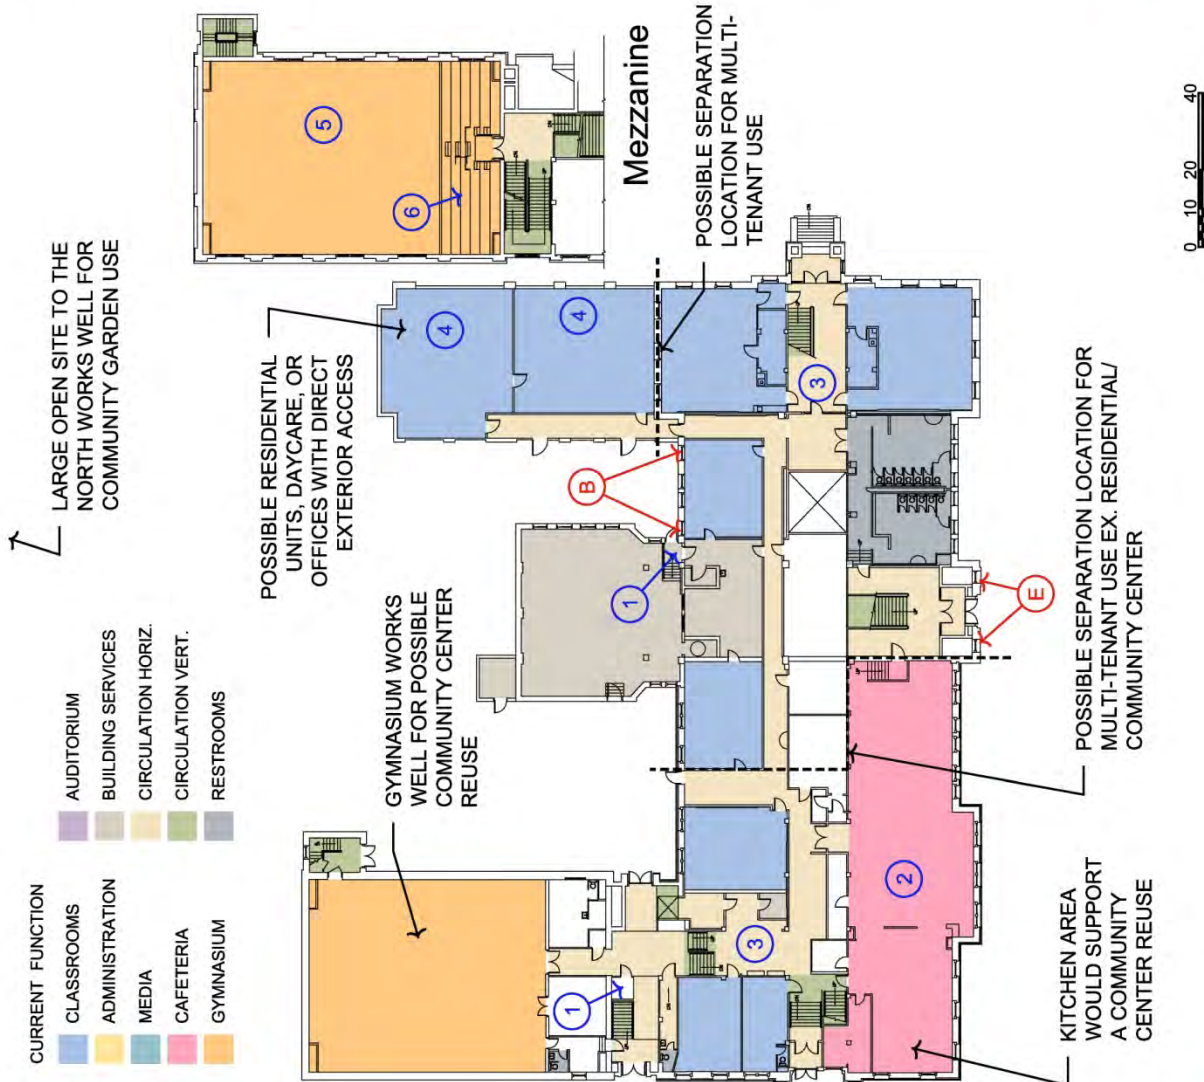
Ground Floor Plan

CONDITION NOTES

- A. Movement at stone coping at roof
- B. Damaged/rusted window lintels
- C. Concrete chimney caps damaged
- D. Organic growth in mortar joints at roof parapet
- E. Damage stone masonry at entry

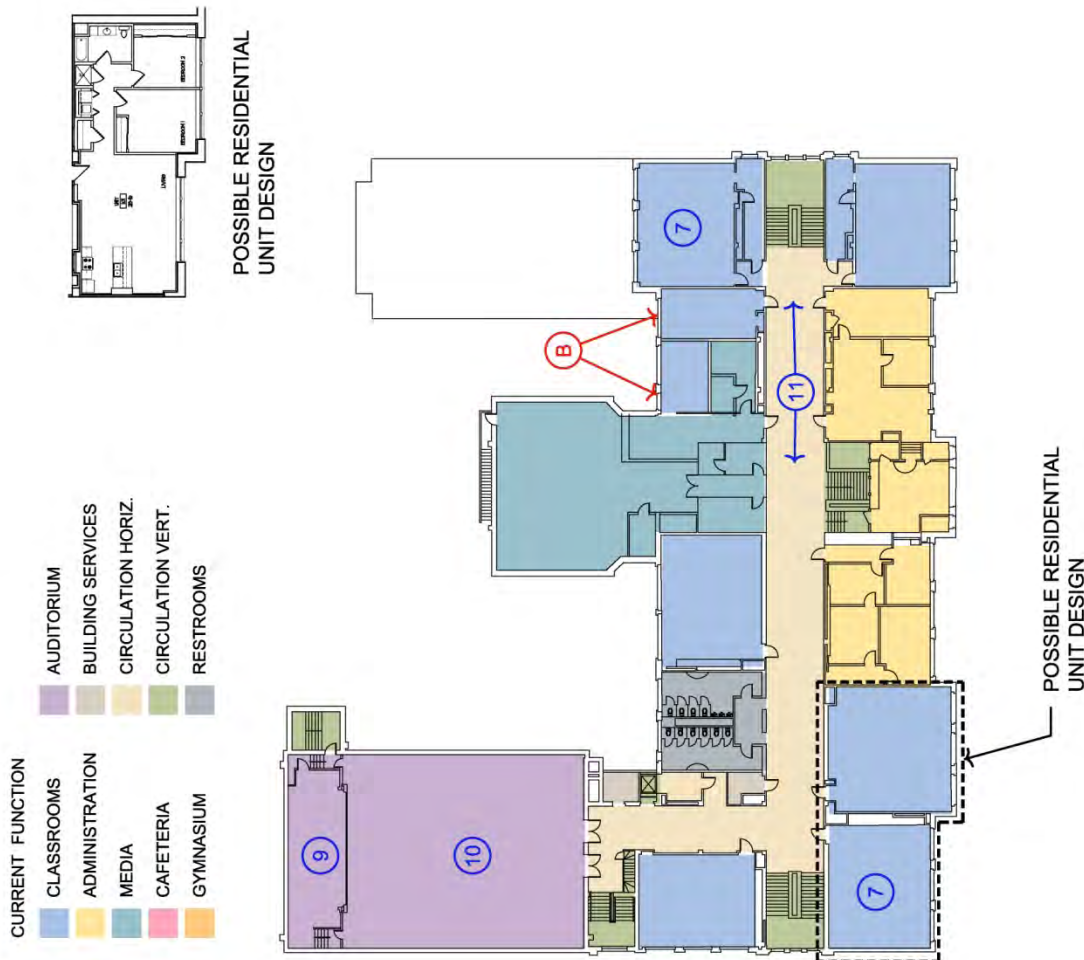
First Floor Plan

CONDITION NOTES

- A. Movement at stone coping at roof
- B. Damaged/rusted window lintels
- C. Concrete chimney caps damaged
- D. Organic growth in mortar joints at roof parapet
- E. Damage stone masonry at entry

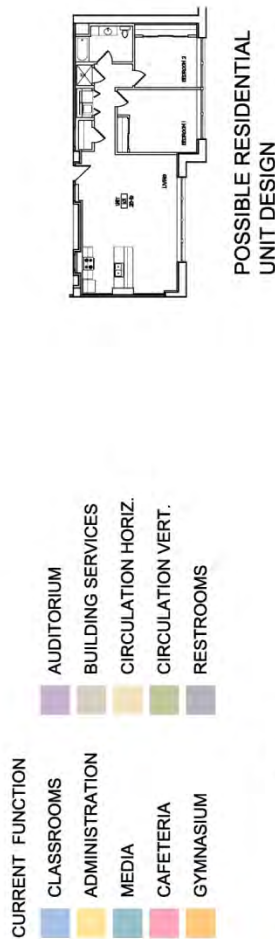
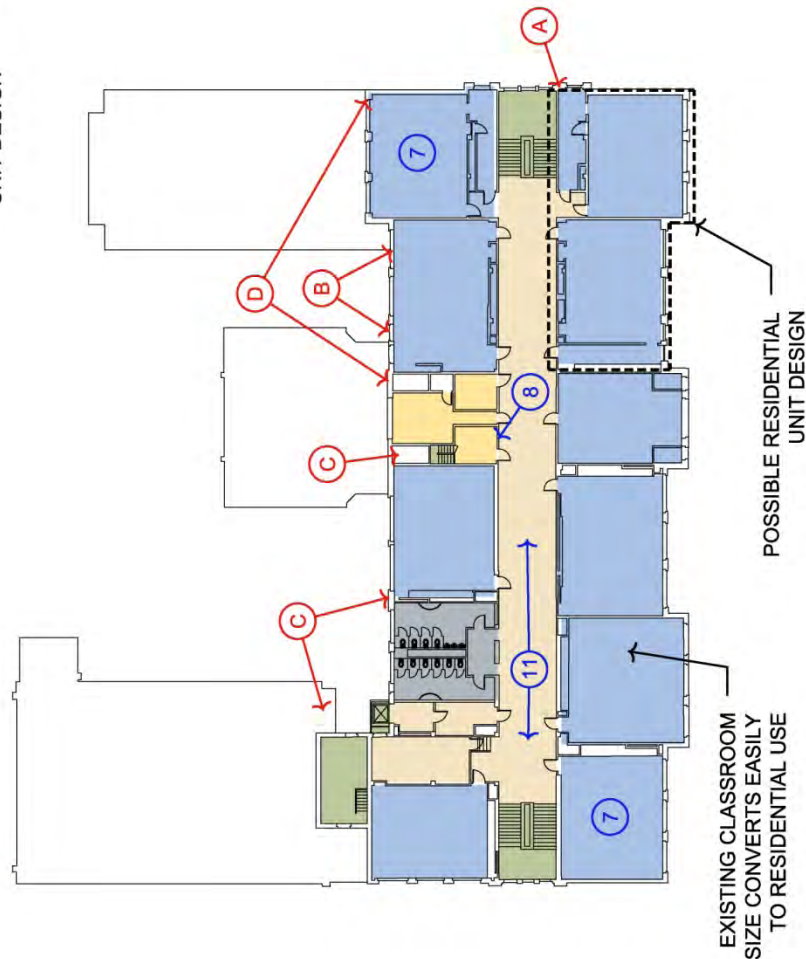
Second Floor Plan

CONDITION NOTES

- A. Movement at stone coping at roof
- B. Damaged/rusted window lintels
- C. Concrete chimney caps damaged
- D. Organic growth in mortar joints at roof parapet
- E. Damage stone masonry at entry
