# Westport Middle

300 E. 39<sup>th</sup> Street

## Historical Brief

## REUSE ASSESSMENT

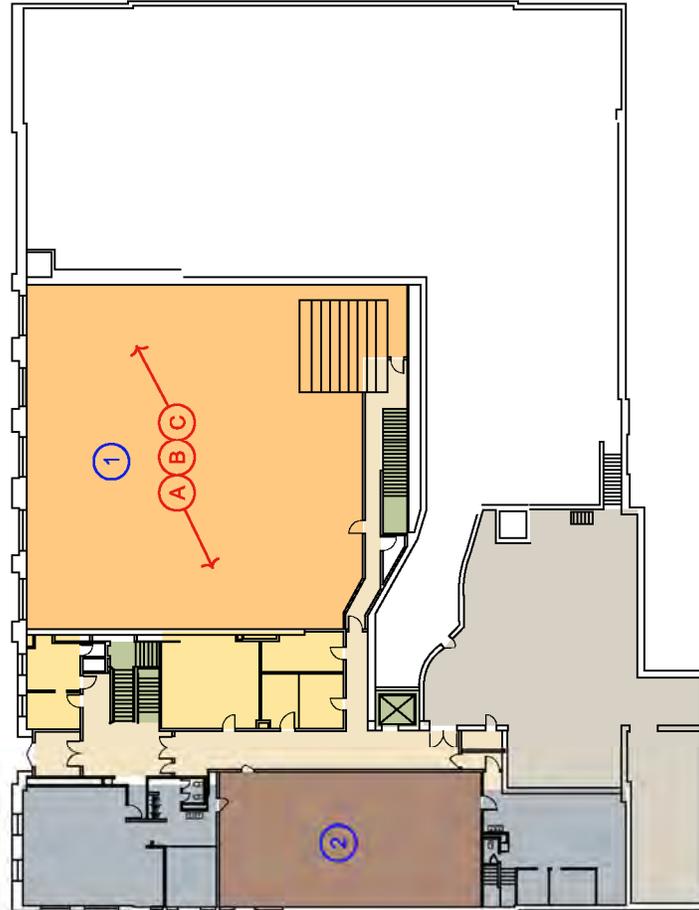
## Sub Basement

- A. Standing water in this area
- B. Damaged flooring in this area
- C. Peeling paint in this area
- D. Damaged concrete/sediment accumulation
- E. Damaged asphalt
- F. Water damage at walls and ceiling
- G. Damaged ceiling tiles
- H. Water damage at ceiling (typical at 4th floor)

THIS LEVEL COULD NOT BE DIVIDED FOR MULTIPLE USES UNLESS MORE EXITS ARE PROVIDED

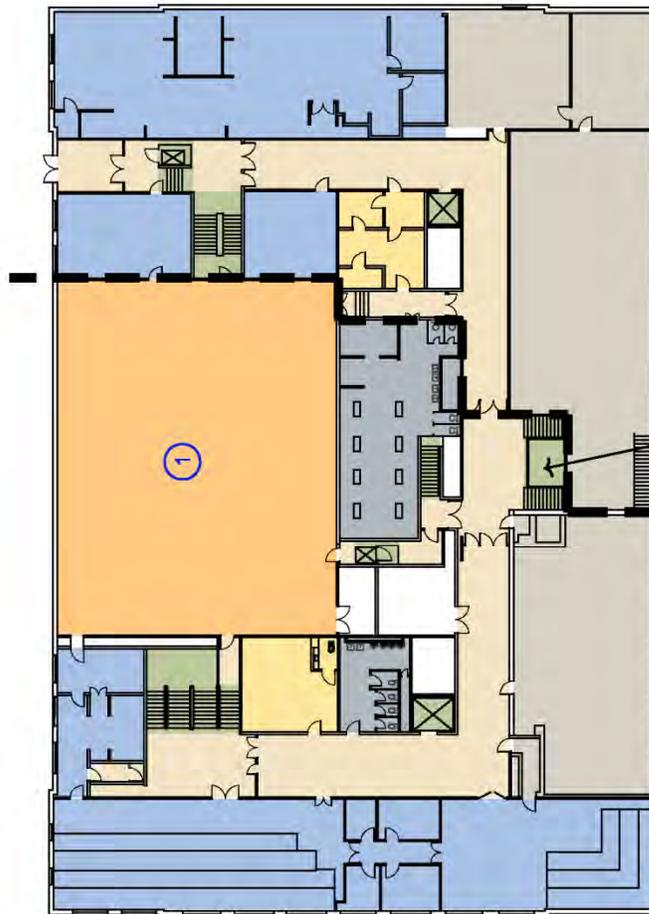
Basement

- A. Standing water in this area
- B. Damaged flooring in this area
- C. Peeling paint in this area
- D. Damaged concrete/sediment accumulation
- E. Damaged asphalt
- F. Water damage at walls and ceiling
- G. Damaged ceiling tiles
- H. Water damage at ceiling (typical at 4th floor)

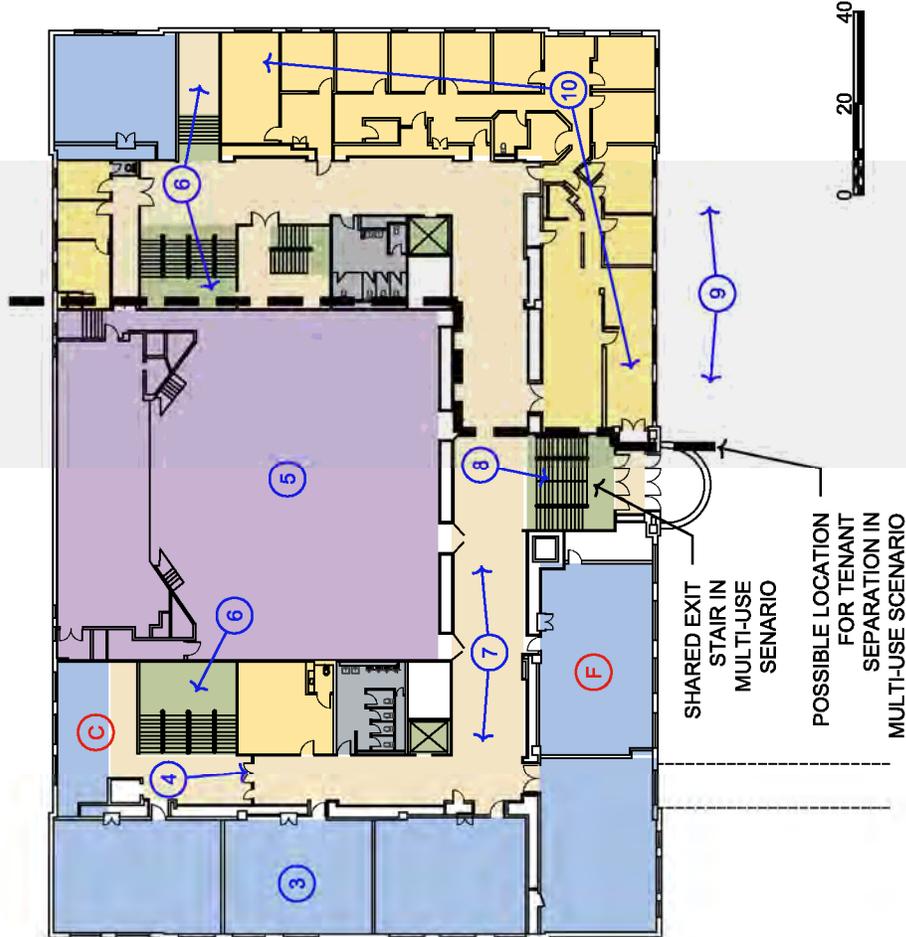
First Floor

- A. Standing water in this area
- B. Damaged flooring in this area
- C. Peeling paint in this area
- D. Damaged concrete/sediment accumulation
- E. Damaged asphalt
- F. Water damage at walls and ceiling
- G. Damaged ceiling tiles
- H. Water damage at ceiling (typical at 4th floor)

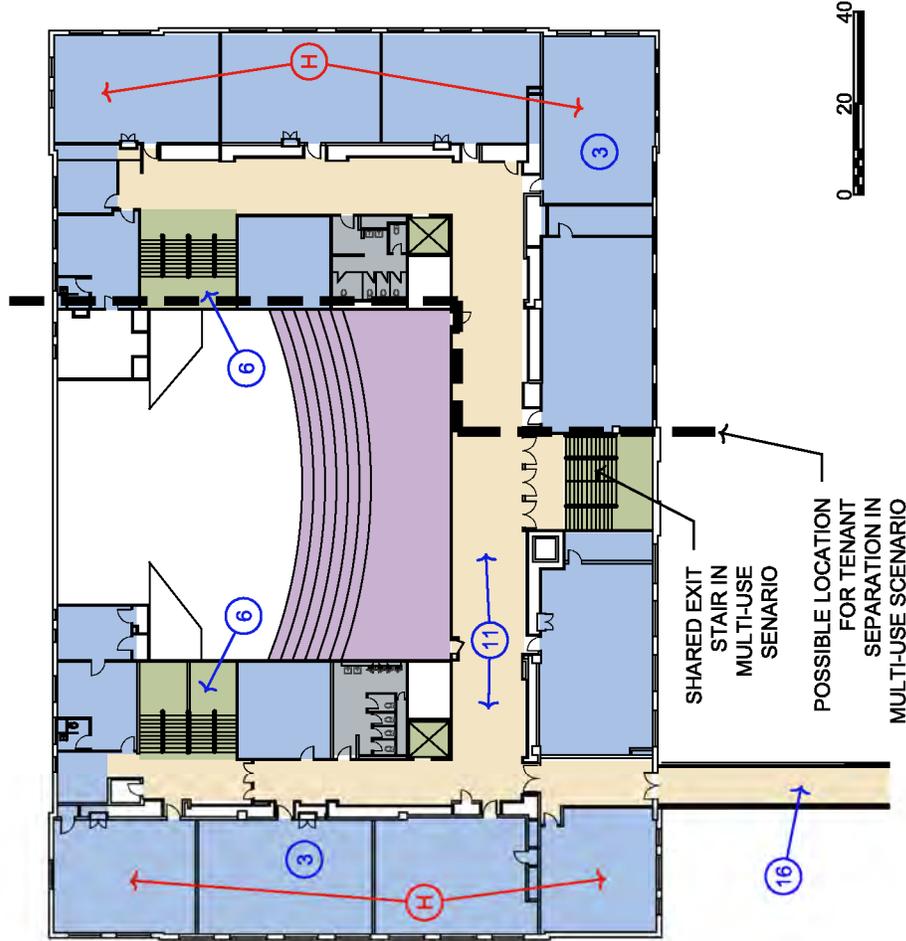
Second Floor  
(Third - Fourth Similar)

- A. Standing water in this area
- B. Damaged flooring in this area
- C. Peeling paint in this area
- D. Damaged concrete/sediment accumulation
- E. Damaged asphalt
- F. Water damage at walls and ceiling
- G. Damaged ceiling tiles
- H. Water damage at ceiling (typical at 4th floor)

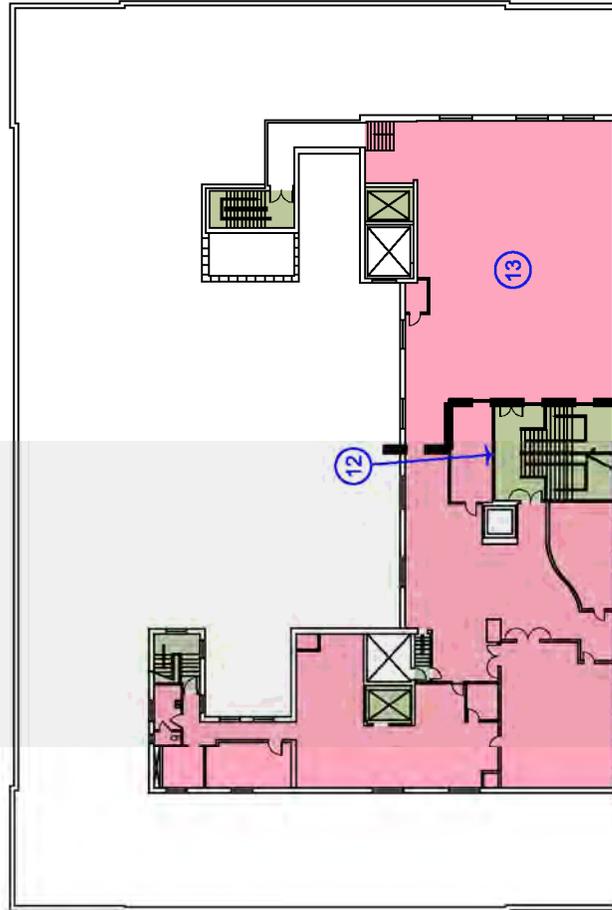
Fifth Floor

- A. Standing water in this area
- B. Damaged flooring in this area
- C. Peeling paint in this area
- D. Damaged concrete/sediment accumulation
- E. Damaged asphalt
- F. Water damage at walls and ceiling
- G. Damaged ceiling tiles
- H. Water damage at ceiling (typical at 4th floor)

SHARED EXIT STAIR IN MULTI-USE SENARIO

POSSIBLE LOCATION FOR TENANT SEPARATION IN MULTI-USE SCENARIO

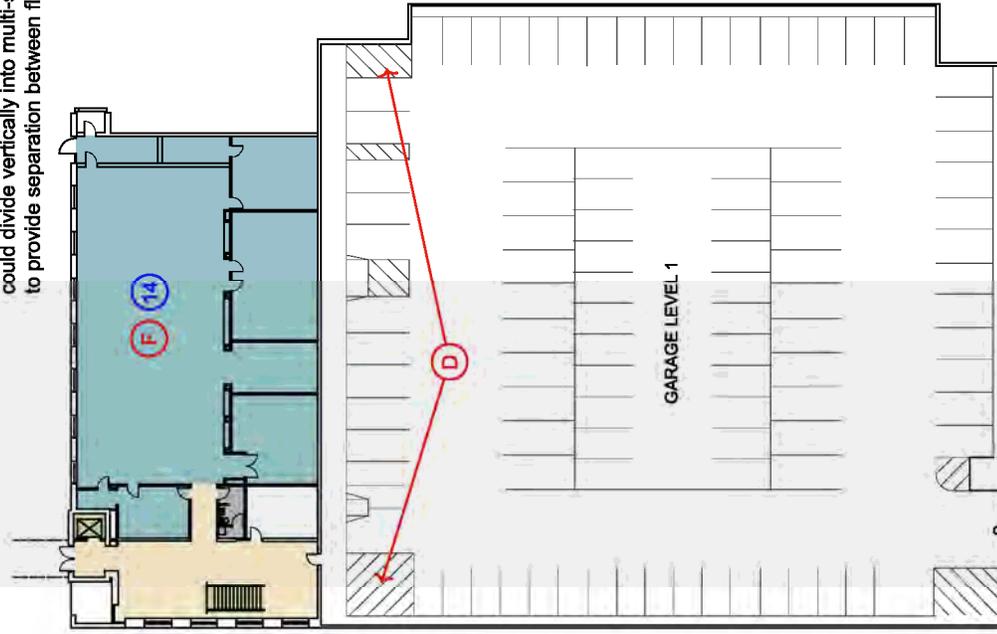
1992 Addition - First Floor

16. Walkway to 1992 addition and parking garage
  17. TV Studio
- CONDITION NOTES**
- A. Standing water in this area
  - B. Damaged flooring in this area

- C. Peeling paint in this area
  - D. Damaged concrete/sediment accumulation
  - E. Damaged asphalt
  - F. Water damage at walls and ceiling
  - G. Damaged ceiling tiles

- H. Water damage at ceiling (typical at 4th floor)

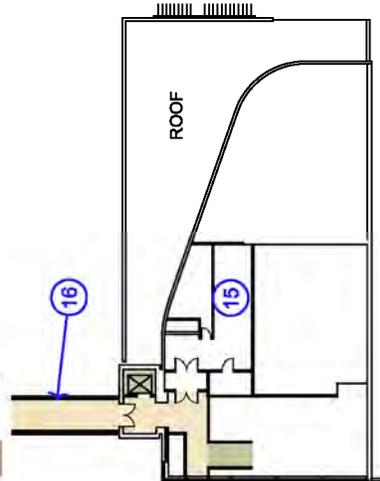
1992 Addition - Third Floor

- A. Standing water in this area
- B. Damaged flooring in this area
- C. Peeling paint in this area
- D. Damaged concrete/sediment accumulation
- E. Damaged asphalt
- F. Water damage at walls and ceiling
- G. Damaged ceiling tiles
- H. Water damage at ceiling (typical at 4th floor)
