REUSE STRATEGY AND ACTION PLAN

WESTPORT HIGH + WESTPORT MIDDLE SCHOOL SITES

315 & 300 E 39th Street, Kansas City, Missouri 64111

KANSAS CITY PUBLIC SCHOOLS August 28, 2013

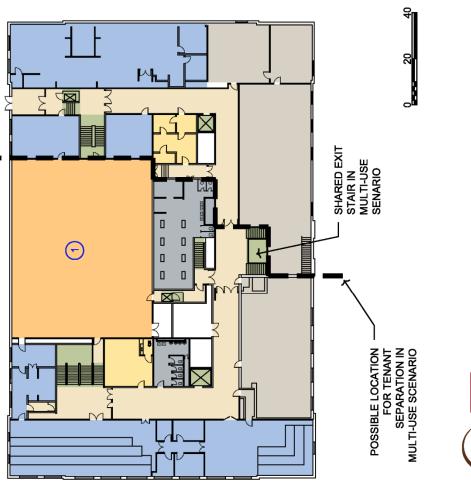
Gymnasium - wood floors and steel

- Damaged flooring in this area Standing water in this area <u>خ من</u> ن ض
 - Peeling paint in this area
- Damaged concrete/sediment
 - accumulation
 - Damaged asphalt
- Water damage at walls and ceiling ய்டீர்
 - Damaged ceiling tiles
- Water damage at ceiling (typical at 4th floor)

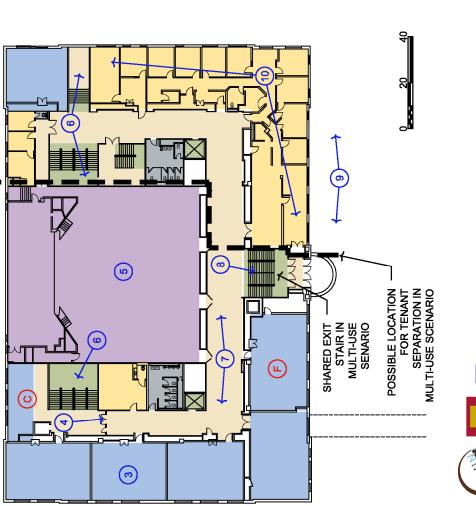
Gymnasium - wood floors and steel

- and carpet floors, acoustical grid ceilings
 - 16. Walkway to 1992 addition and
 - parking garage 17. TV Studio
- CONDITION NOTES
- Standing water in this area
- Damaged flooring in this area
- Peeling paint in this area <u>خ من ن</u> ض
- Damaged concrete/sediment
 - accumulation
 - Damaged asphalt ш
- Water damage at walls and ceiling
- Damaged ceiling tiles ட்ல்
- Water damage at ceiling (typical at
