315 E. 39th Street

REUSE ASSESSMENT

15 September 2011 Westport High - 1

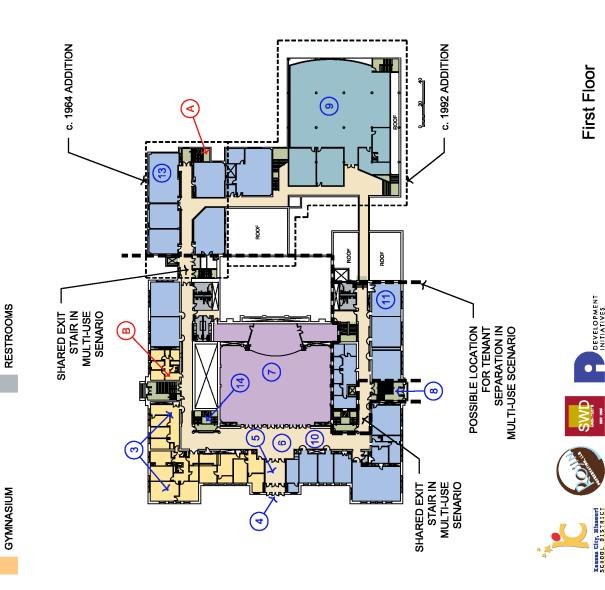
Graffiti on building exterior

Hole in wood floor

CONDITION NOTES Graffiti in stairwell

Peeling paint at ceiling

Broken window

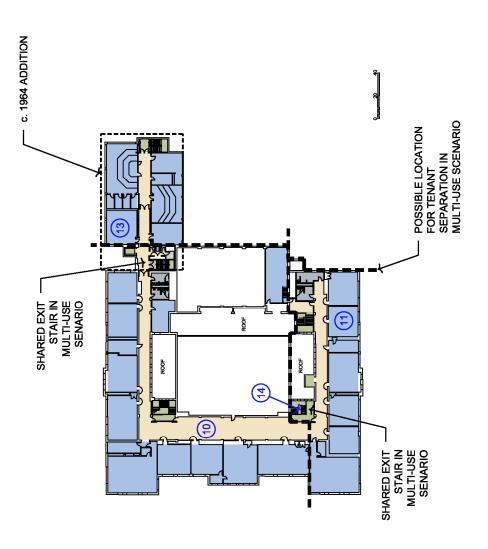
Third Floor

Graffiti on building exterior

Hole in wood floor

CONDITION NOTES Graffiti in stairwell

Peeling paint at ceiling

Broken window
