Willard

5015 Garfield

REUSE ASSESSMENT

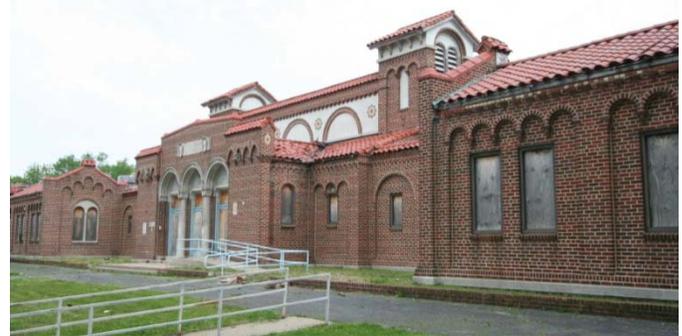
BUILDING/SITE ASSESSMENT: Building is in fair to poor condition. Substantial rehabilitation will be required for any reuse. The multilevel design also presents accessibility challenges. Direct exterior access from many classrooms would be an asset for residential or office use or for a multi-tenant scenario. While classroom size and features support reuse as multi-family housing, the building would accommodate only 15 +/- units. This small number would require additional new construction on the property to make residential development feasible. The building's exterior and interior design limit the visibility required for good retail use but could work for office occupancy or business incubator with classrooms converted into multi-person office space, although the amount of office space compared to circulation space is not highly efficient. The large paved playground on the south side of the building offers opportunities for additional new construction or for community use of the grounds (garden, farmer's market, open space, playground, etc.)
