# Swinney

1106 West 47<sup>th</sup> Street

## REUSE ASSESSMENT

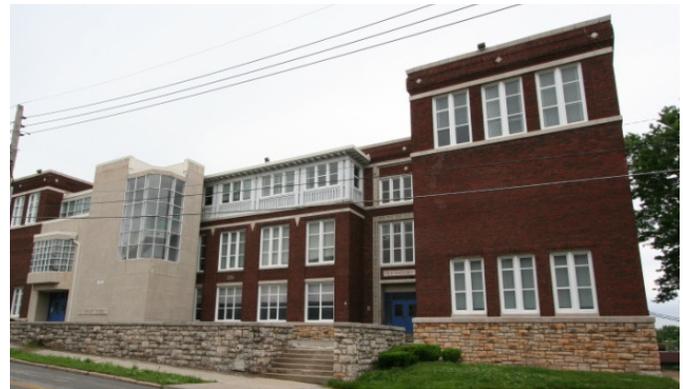
**BUILDING/SITE ASSESSMENT:** The building is in very good condition. It could easily reopen as an elementary school. Its size and layout are also readily adaptable for multi-family housing (24 +/- units). Classroom size converts well into a single bedroom apartment or combines well into a two bedroom apartment. The number and configuration of stairs and exits supports the division of the building for multiple tenants (such as housing + office). The building's exterior and interior design limit the visibility required for good retail use. It could work for office occupancy or as a business incubator with classrooms converted into multi-person office space, although the ratio of circulation space to lease space is inefficient. This building is fully air conditioned, which may expand reuse options under a short-term lease scenario. Uses other than office or education will typically require installation of a fire sprinkler system (a community center may also be exempt depending on overall sq. footage and location of exits). The large playground north of the building offers opportunities for community use of the grounds (garden, open space, playground).
